VILLAGE OF HALKIRK

INFRASTRUCTURE ASSESSMENT AND 10-YEAR CAPITAL PLAN

Date: September 30, 2021
Project Number: 4460-005-00

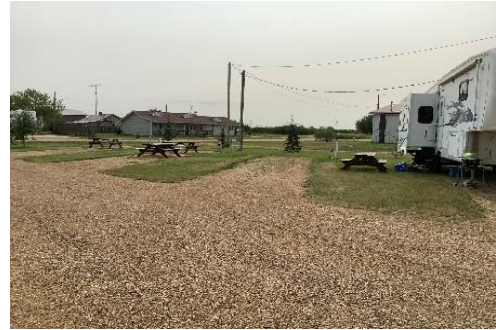
A total of \$9,500 of deficiencies was noted for the next ten years including the replacement of leaking hydrant piping for camping services and replacement of some broken plug receptacle covers.

Figure 2.1: Berry Street Campground

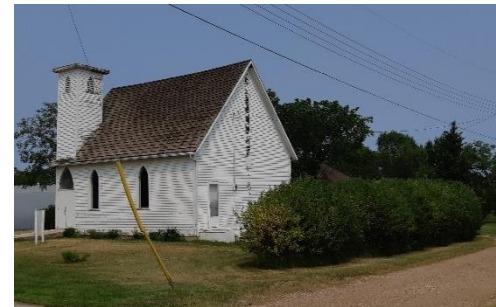
Figure 2.2: Church Exterior

- No handheld fire extinguishers are located in the building.
- The Steeple is in poor condition and allows pigeons in the building.
- Wood fascia, siding, ceiling, and flooring requires repainting.
- Incandescent fixtures should be replaced with LED bulbs for energy efficiency.
- No exhaust for congregation space.
- Furnace is in poor condition.
- "Halkirk Community Church" sign is in fair condition and should be replaced.
- Cedar shingles are reaching the end of their theoretical life.
- Tree branches overhang the north building eavestrough and may block flow.

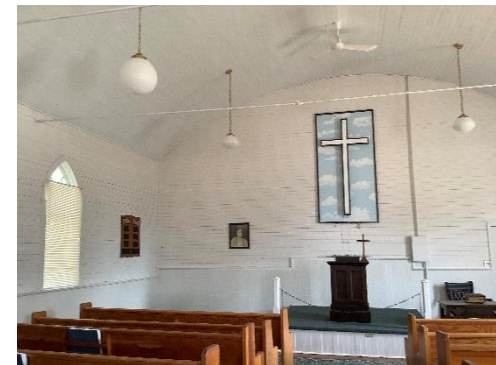
Figure 2.3: Church Interior

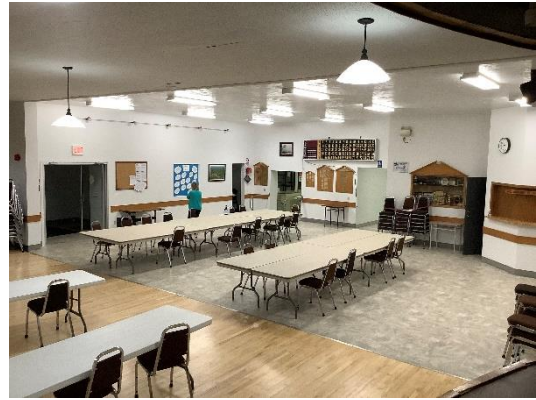
Figure 2.4: Community Hall Interior

- No exhaust in basement washrooms.
- No fire suppression on kitchen range exhaust hood.
- Fire pulls, smoke and heat detectors, and bell annunciators located throughout the building are past their expected life and the main panel could not be located.
- Front entry cement pad heaved due to tree roots.
- Stucco exterior shows some cracks and damage throughout the building.
- T-8 fluorescent fixtures and incandescent fixtures should be replaced with LED bulbs for energy efficiency.
- Fixtures in abandoned washrooms should be decommissioned completely and removed.
- “Halkirk Community Hall” sign has some minor peeling of paint.
- The basement gets some dampness at spring melt and heavy rain. It is likely the water table around the building. Weeping tile and waterproofing membrane are recommended to be installed around the foundation.

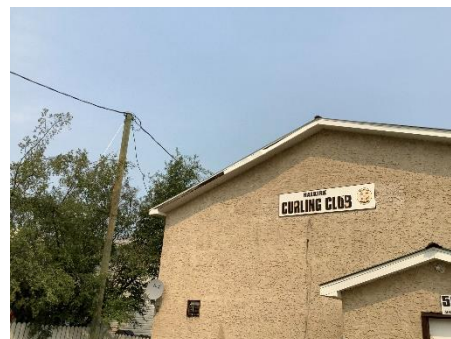
Figure 2.5: Curling Rink Exterior

The Curling Rink is generally in poor condition. A total cost of \$282,600 of deficiencies were noted to be completed in the next ten years. A summary of the deficiencies is as follows:

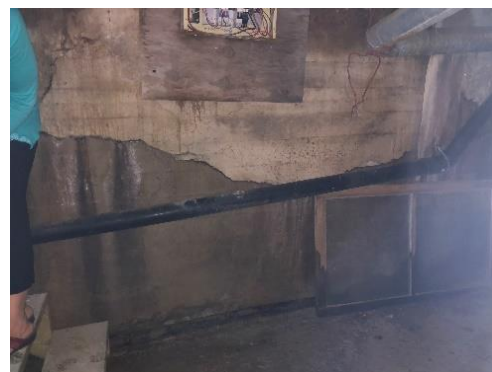
- Excess moisture and mold growth in the basement and mechanical room.
- Door to the basement is warped.
- Basement foundation walls are in critical condition and there is evidence that lateral pressure exerted by soil outside the foundation has at some point exceeded what the foundation can support. Additional investigation is required to determine suitable remediation.

Figure 2.6: Curling Rink Basement Wall

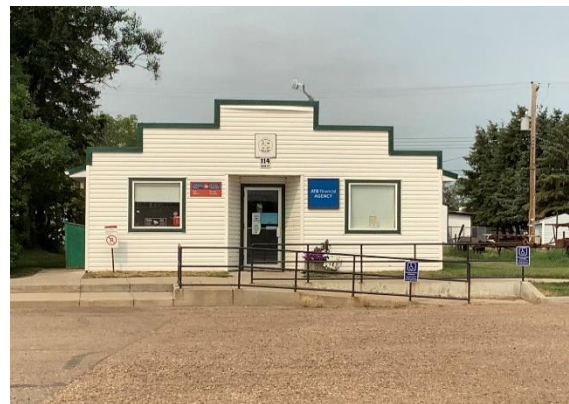
- Some of the vinyl siding is damaged.
- T-8 fluorescent and incandescent fixtures should be replaced with LED bulbs for energy efficiency.
- Painted surfaces and floor should be repainted.

Figure 2.10: Canada Post Office Exterior

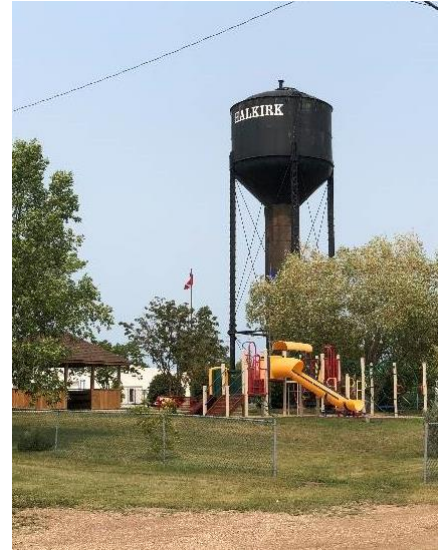
- The plywood on the Water Tower is recommended to be replaced.
- Fence is nearing the end of its expected life.
- Replace existing door.

Figure 2.14: Water Tower and Playground

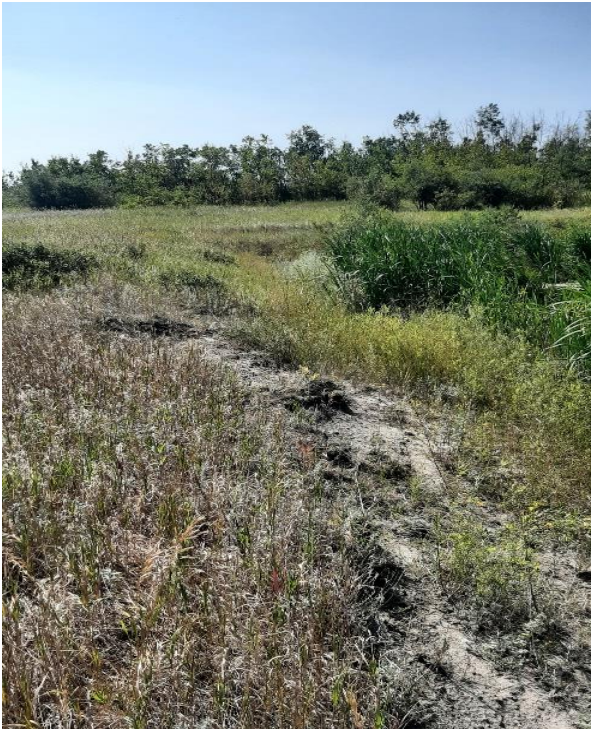
Figure 3.7: South Anaerobic Cell Erosion

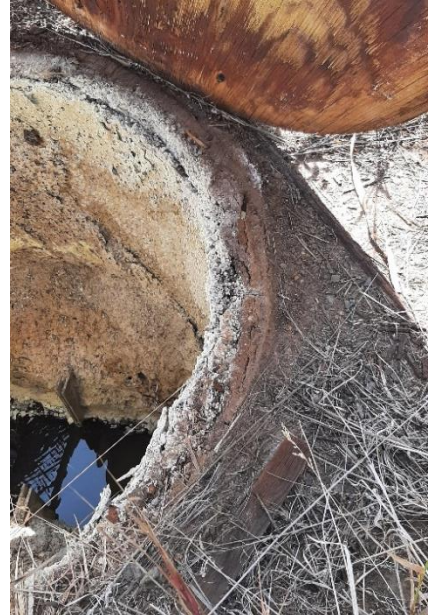
Figure 3.12: Structure 4 Concrete Deterioration

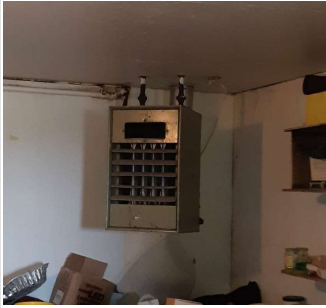
Front entry area is heated by a gas-fired unit heater, in poor condition. Recommended to replace. Arena area is unheated.	\$ 2,000.00

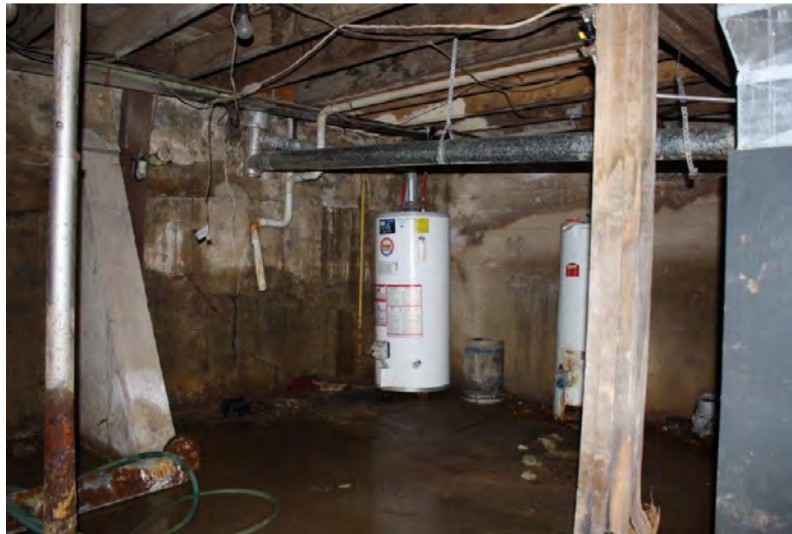
Photograph 7: The Curling Rink basement, noting the wet conditions (June 23, 2021).

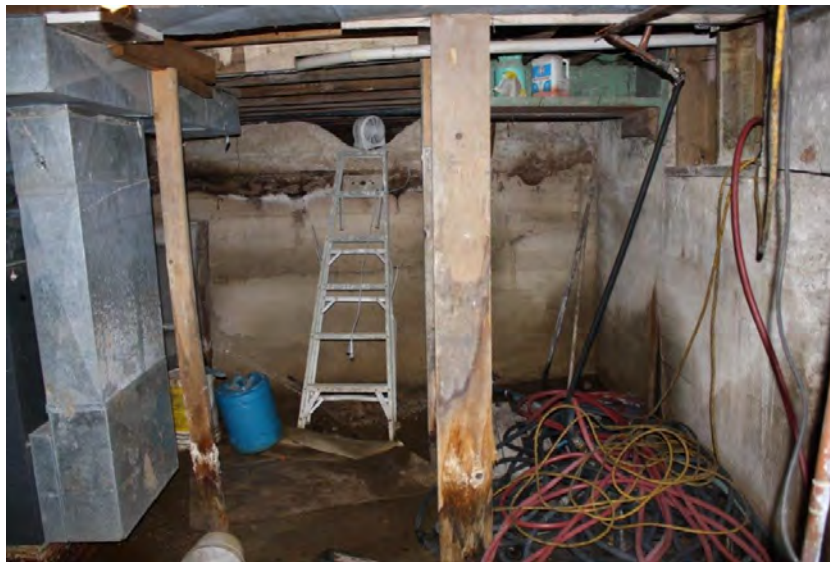
Photograph 8: The Curling Rink basement, noting the water wicking in the wooden pillar and poor condition of the infrastructure (June 23, 2021).

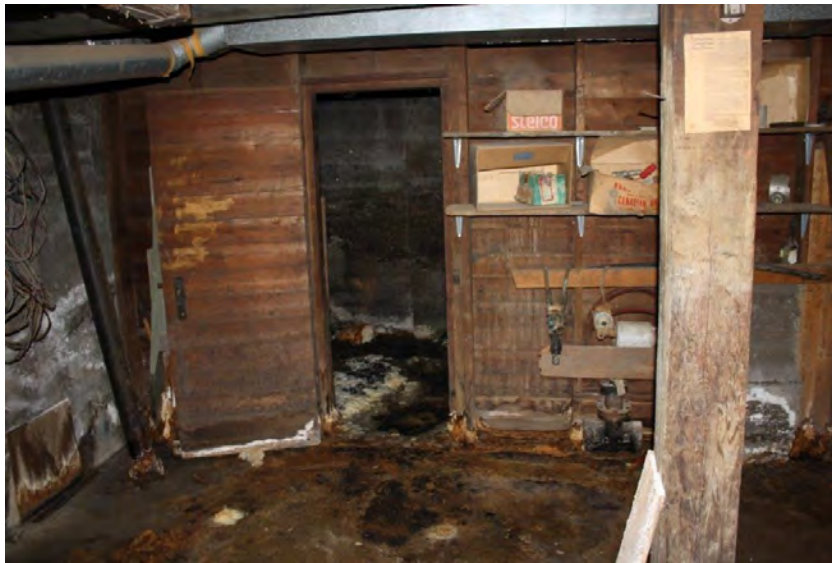
Photograph 5: The Seniors Center basement, noting poor conditions (June 23, 2021).

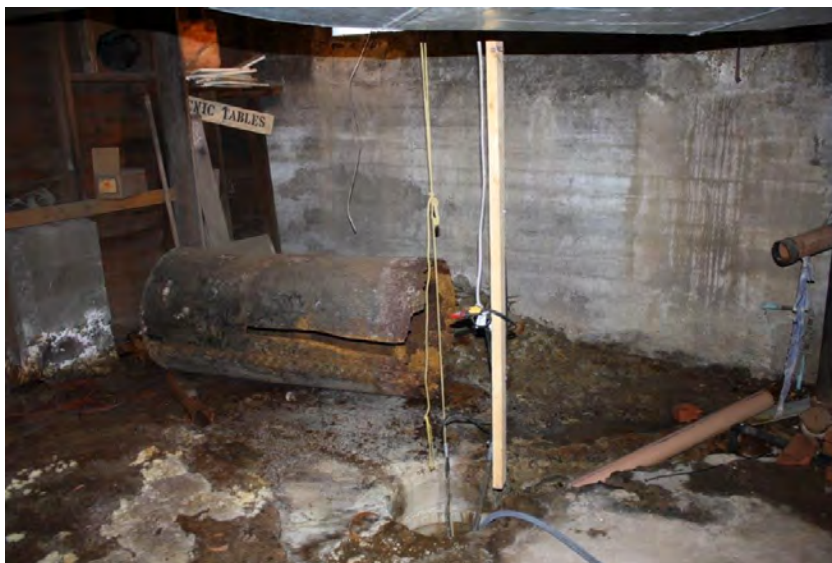
Photograph 6: A storage tank and sump in the Seniors Center basement, noting wet conditions, salt staining and deteriorating infrastructure (June 23, 2021).

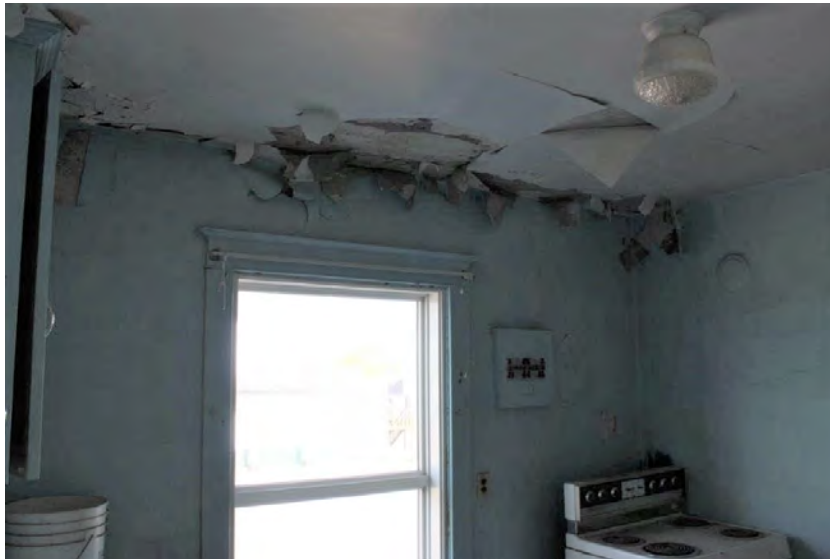
Photograph 12: Water damage on the second floor of the Seniors Center (June 23, 2021).

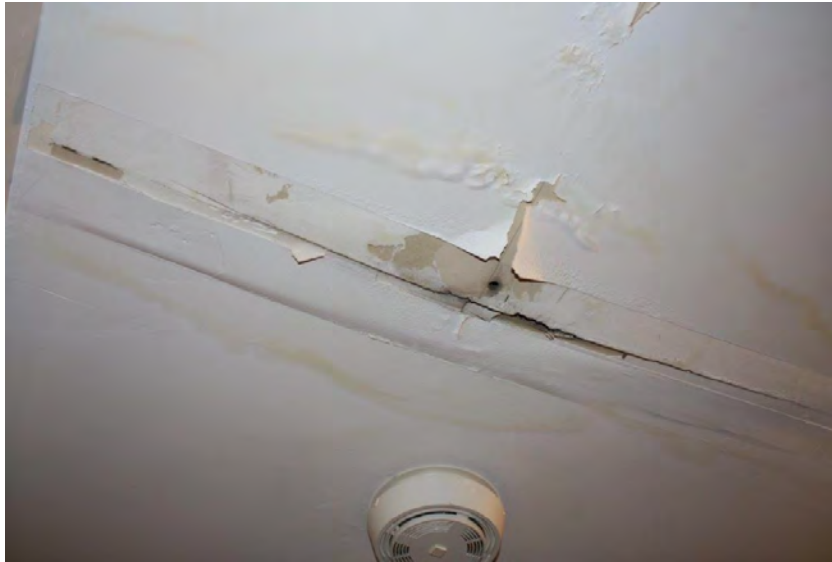
Photograph 31: Water damage in the ceiling of the Community Hall on the second floor (June 23, 2021).
