VILLAGE OF HALKIRK

INFRASTRUCTURE ASSESSMENT AND 10-YEAR CAPITAL PLAN

Date: September 30, 2021
Project Number: 4460-005-00

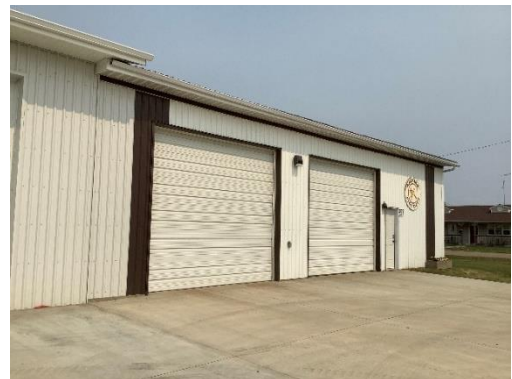
Figure 2.7: Fire Hall Exterior

A total cost of \$23,500 of deficiencies were noted to be completed in the next ten years. A summary of the deficiencies are as follows:

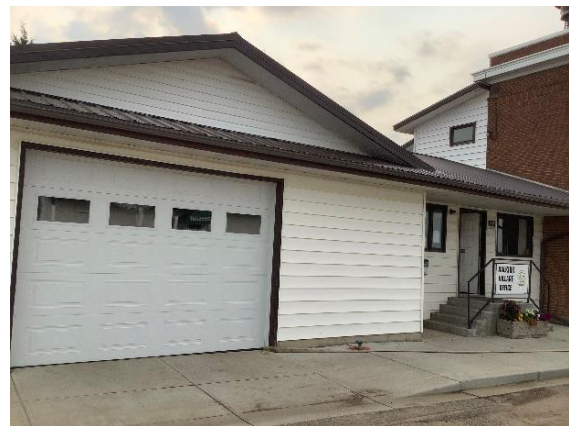
Figure 2.13: Village Office and Public Works Shop Exterior

A total cost of \$182,000 of deficiencies were noted to be completed in the next ten years. A summary of the deficiencies are as follows:

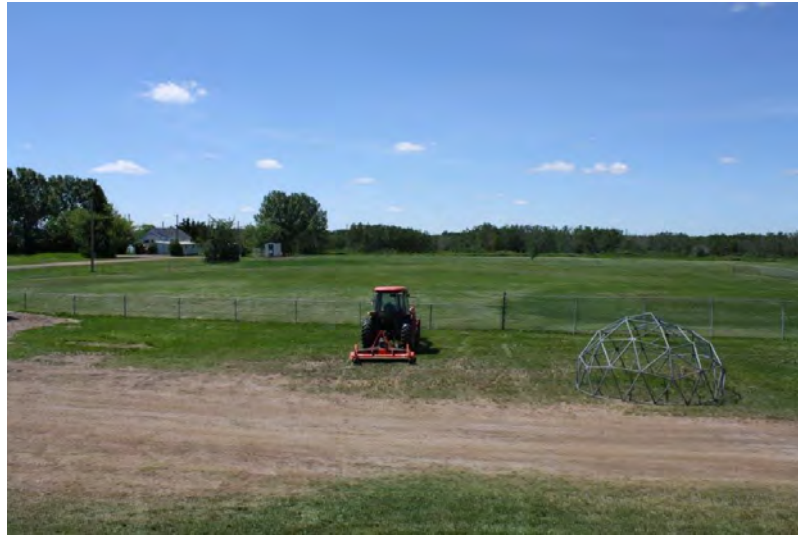
Photograph 1: Looking west across the baseball diamond on the southwest portion of the Campground (June 23, 2021).

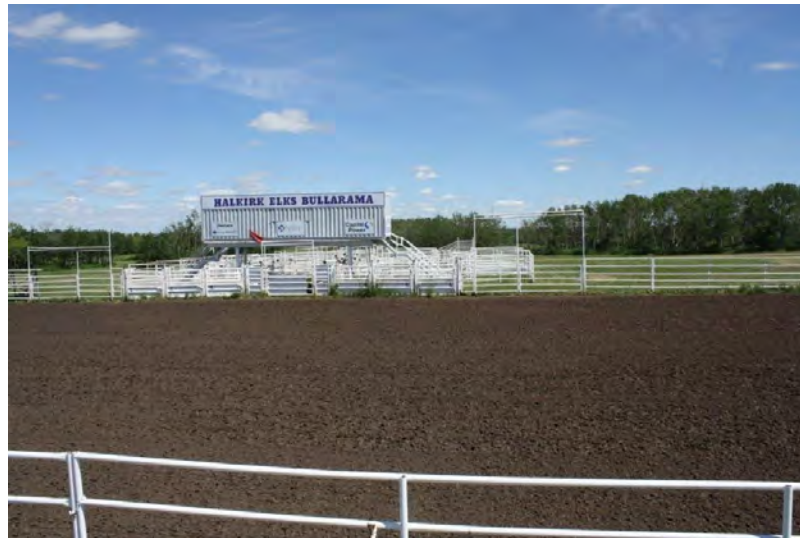
Photograph 2: Looking east over the rodeo grounds on the southeast portion of the Campground (June 23, 2021).

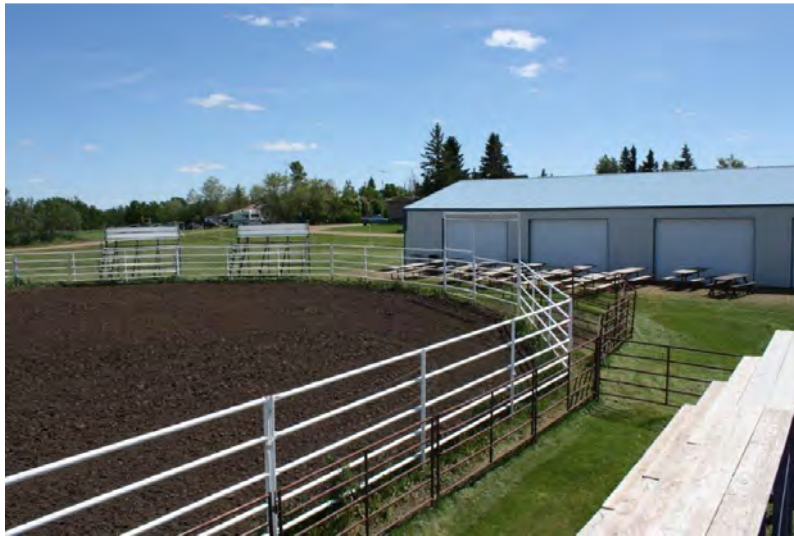
Photograph 3: Looking south over the drink shack in the southeast portion of the Campground (June 23, 2021).

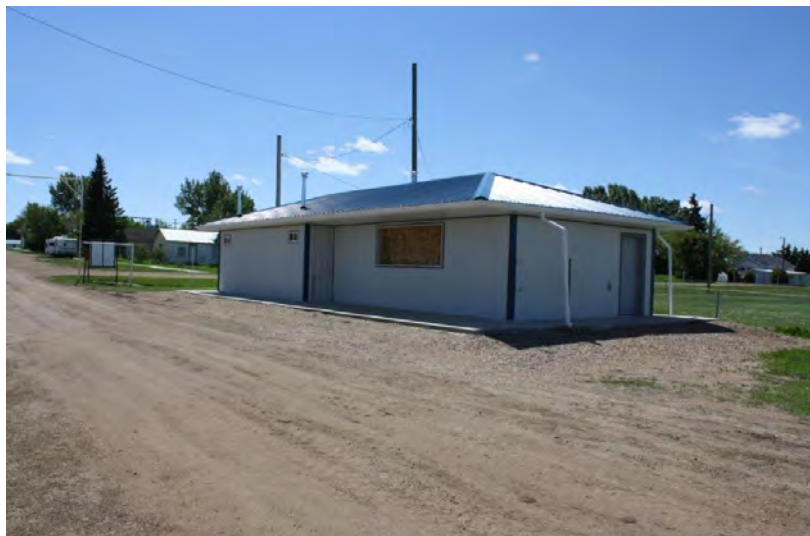
Photograph 4: Looking south at the new washroom and concession near the Main Street entrance of the Campground (June 23, 2021).

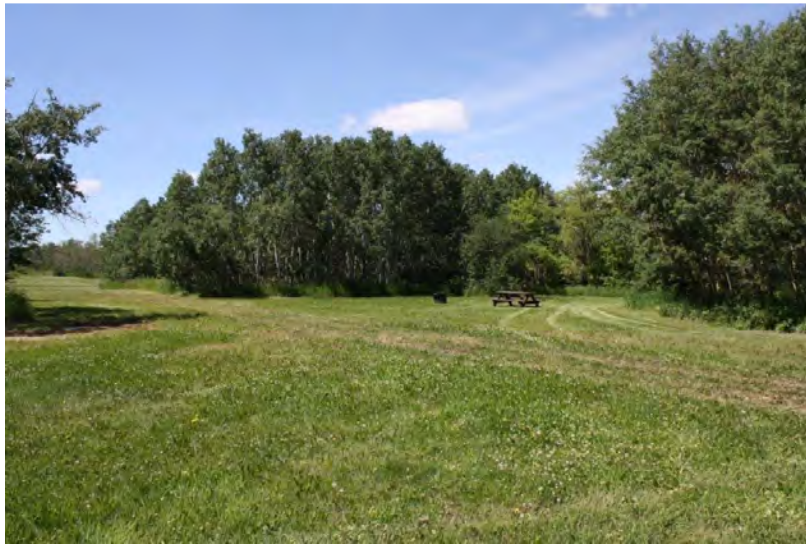
Photograph 5: A typical camp stall on the north portion of the Campground (June 23, 2021).

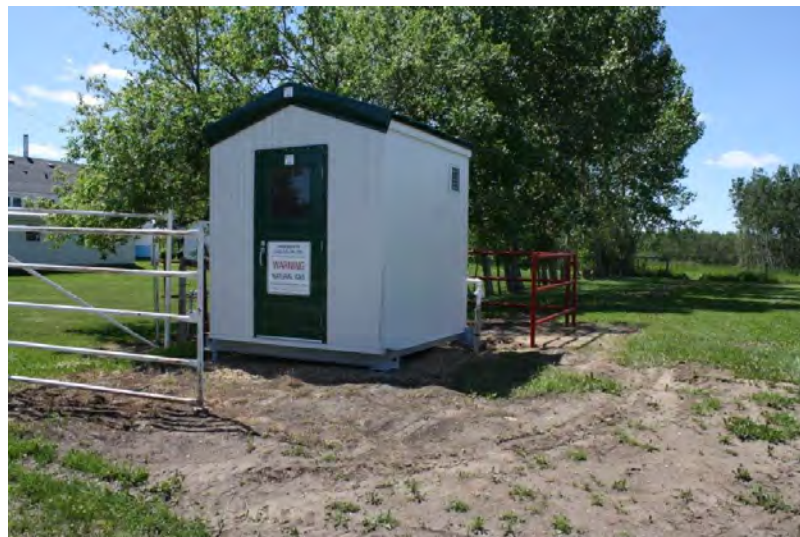
Photograph 6: The Paintearth Gas Co-op Ltd. metering station near the southwest portion of the Campground (June 23, 2021).

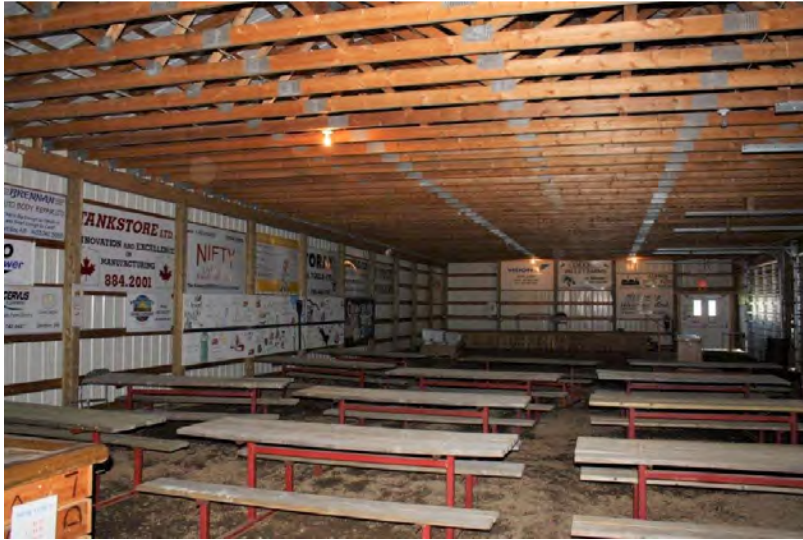
Photograph 7: Looking west across the interior of the drink shack on the Campground (June 23, 2021).

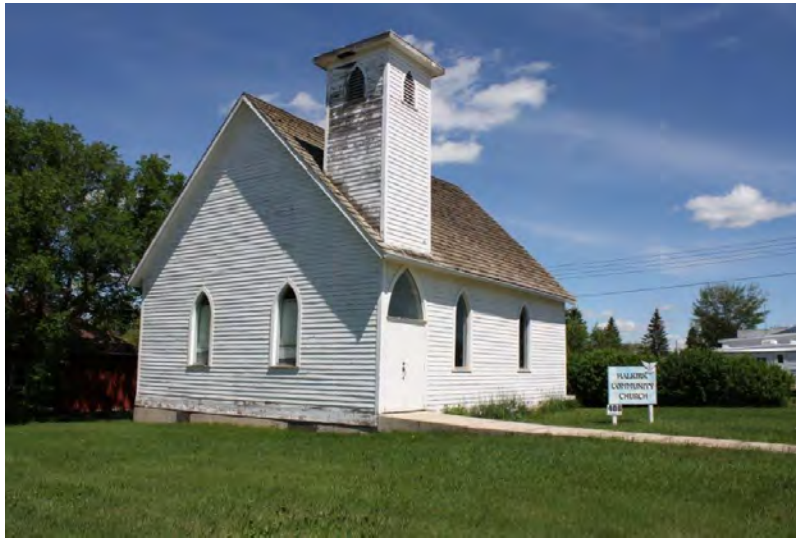
Photograph 1: Looking northeast over the Church from the George Street and Alberta Avenue intersection (June 23, 2021).

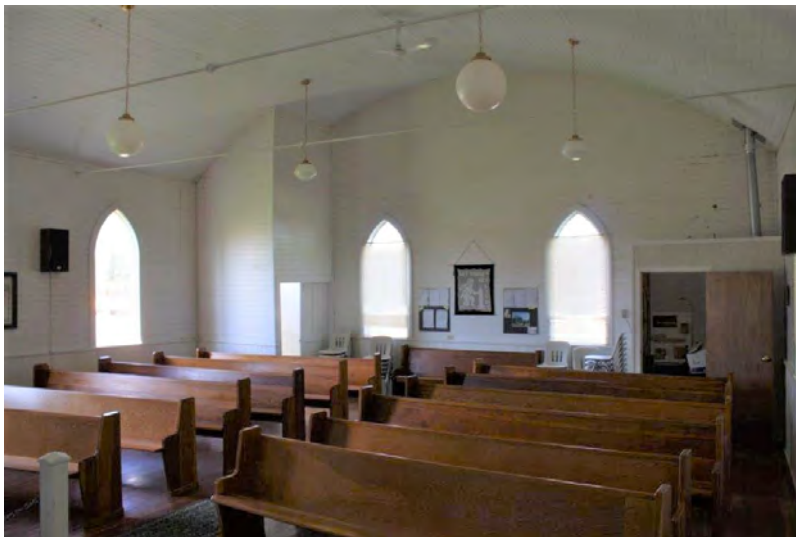
Photograph 2: Looking west from the alter over the interior finishing's of the Church (June 23, 2021).

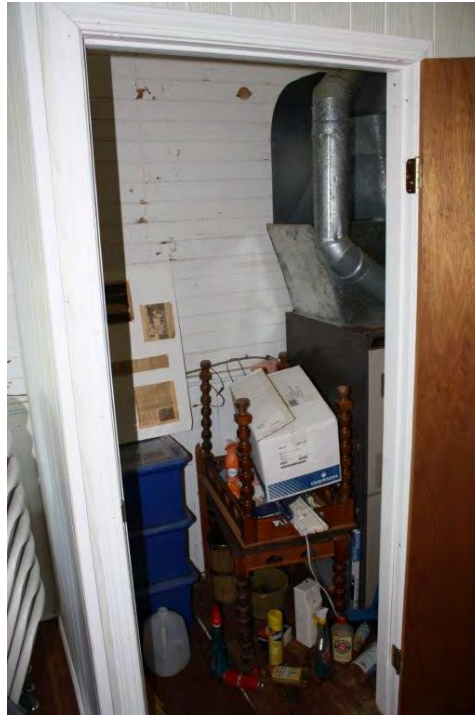
Photograph 3: The furnace in the mechanical room in the northwest portion of the Church (June 23, 2021).

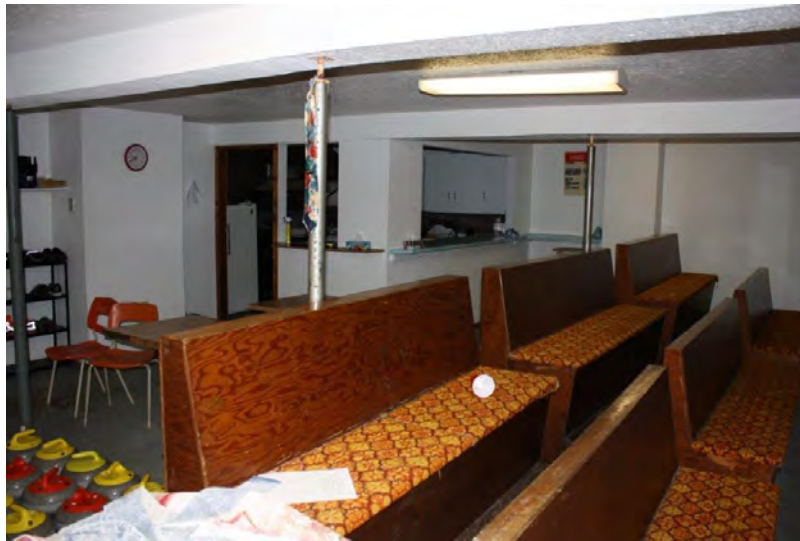
Photograph 5: The main floor viewing area and kitchen in the Curling Rink (June 23, 2021).

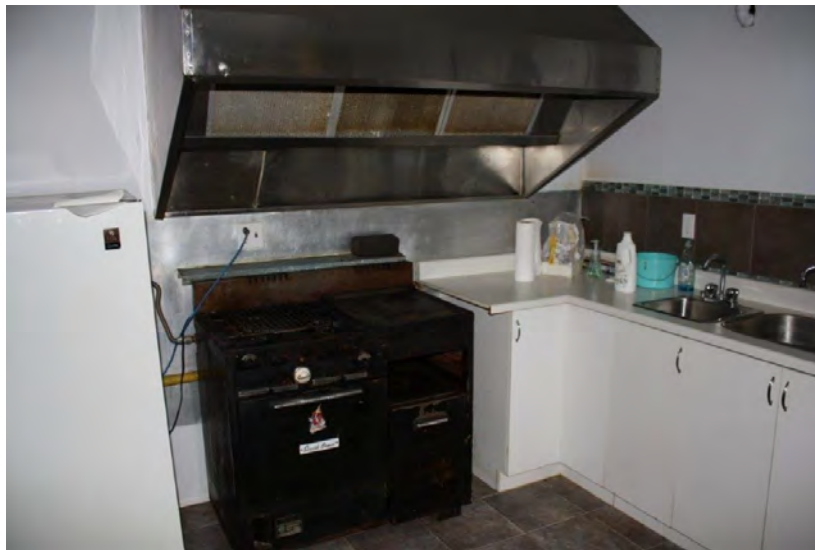
Photograph 6: The main floor kitchen in the Curling Rink (June 23, 2021).

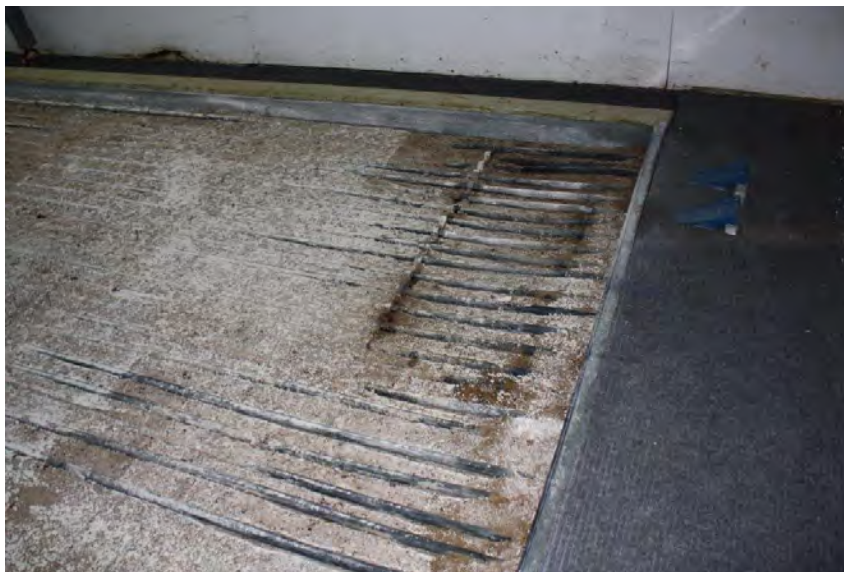
Photograph 10: A close up of the artificial ice system piping within the ice sheets (June 23, 2021).

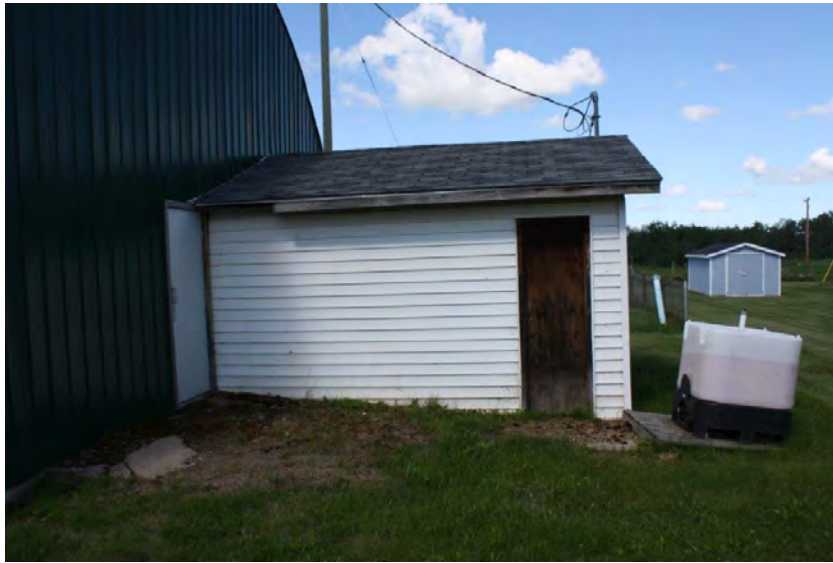
Photograph 11: The addition on the north side of the Curling Rink where the artificial ice system was located along with a plastic tote containing calcium chloride (June 23, 2021).

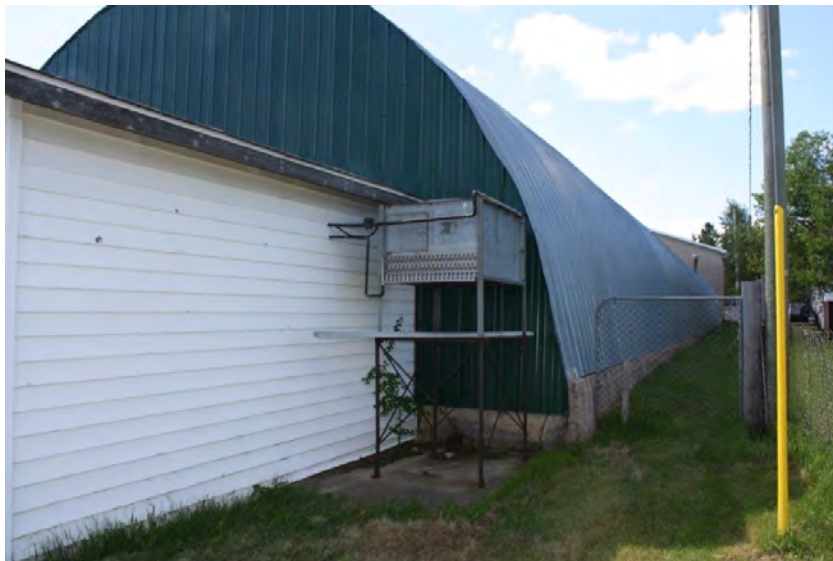
Photograph 12: Components of the artificial ice system, containing freon, west of the addition (June 23, 2021).

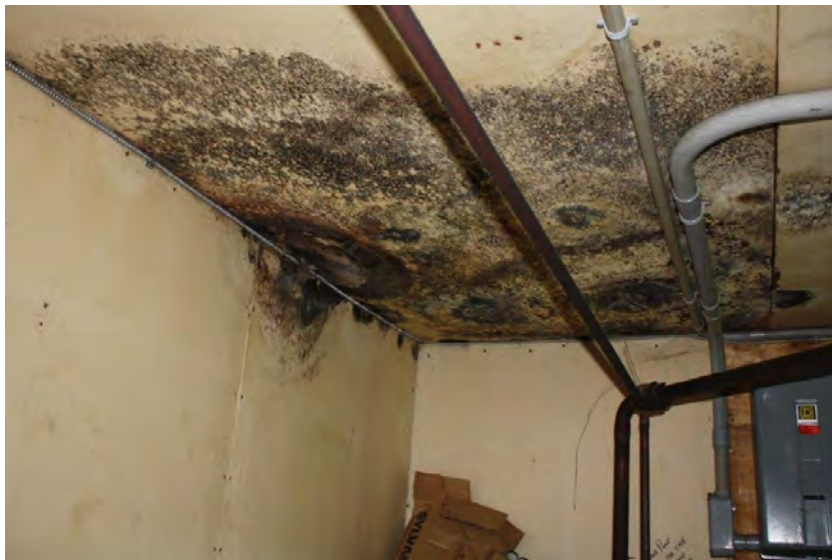
Photograph 14: Mould in the addition on the north side of the Curling Rink (June 23, 2021).

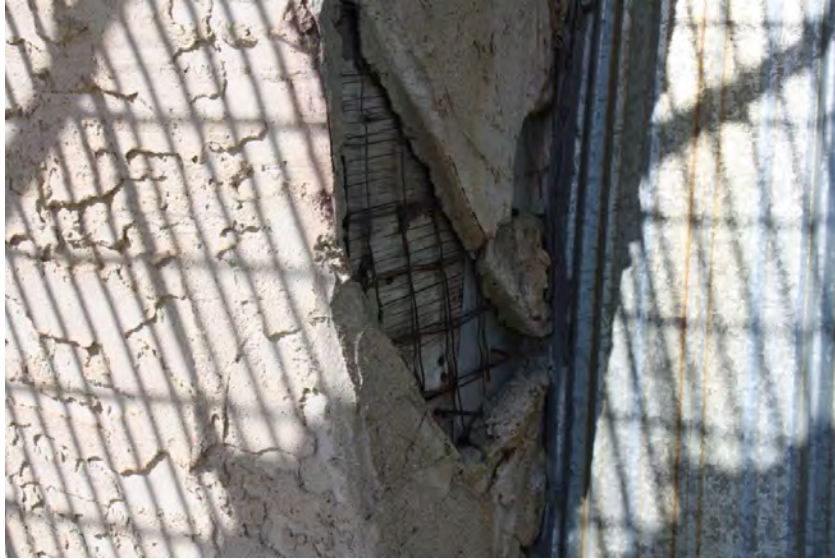
Photograph 15: Exterior finishes on the south portion of the Curling Rink (June 23, 2021).

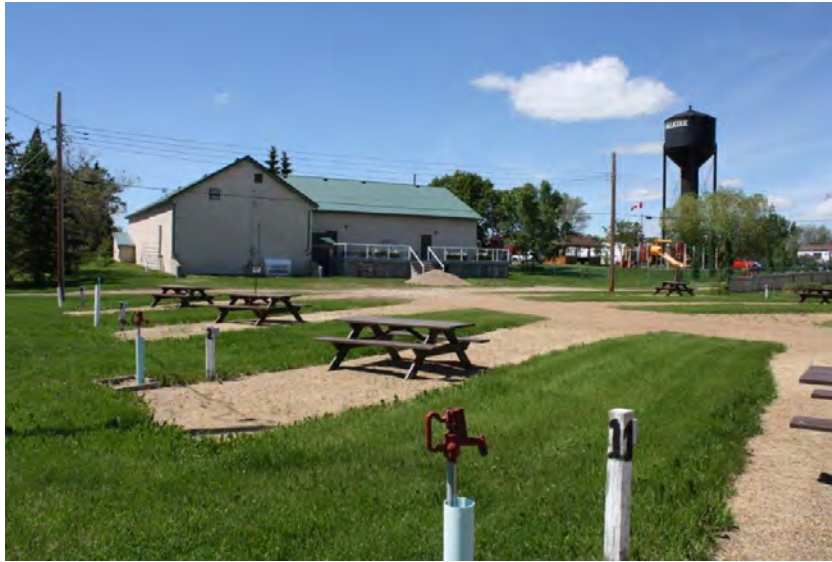
Photograph 1: Looking northwest over the Berry Street Campground towards the Community Hall and Water Tower (June 23, 2021).

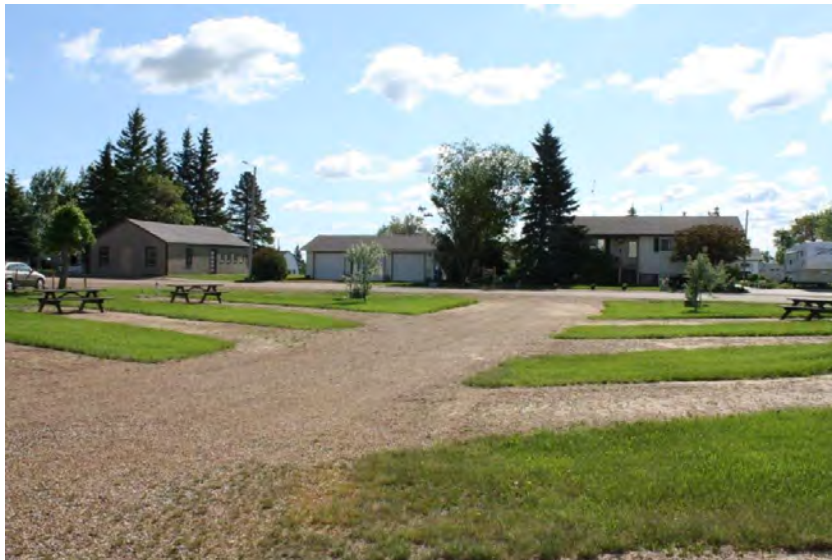
Photograph 2: Looking east across the central portion of the Berry Street Campground (June 23, 2021).

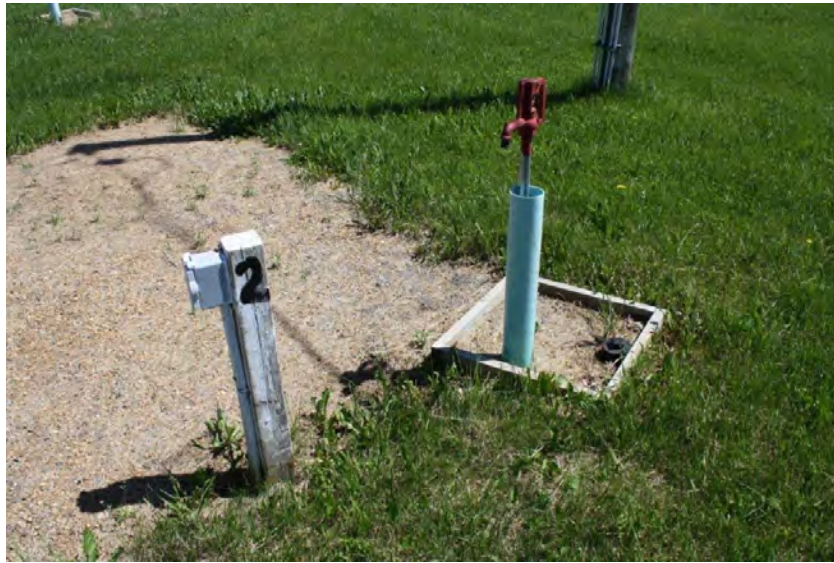
Photograph 3: Typical services including power, water and sewer at a stall within the Berry Street Campground (June 23, 2021).

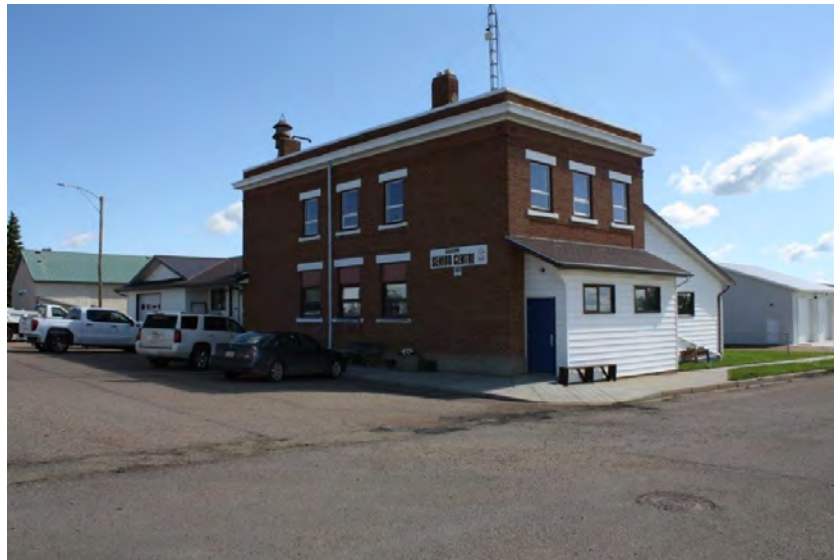
Photograph 4: Looking northeast from Main Street and the Alberta Avenue intersection and the Seniors Center, Village Office and Public Works shop (June 23, 2021).

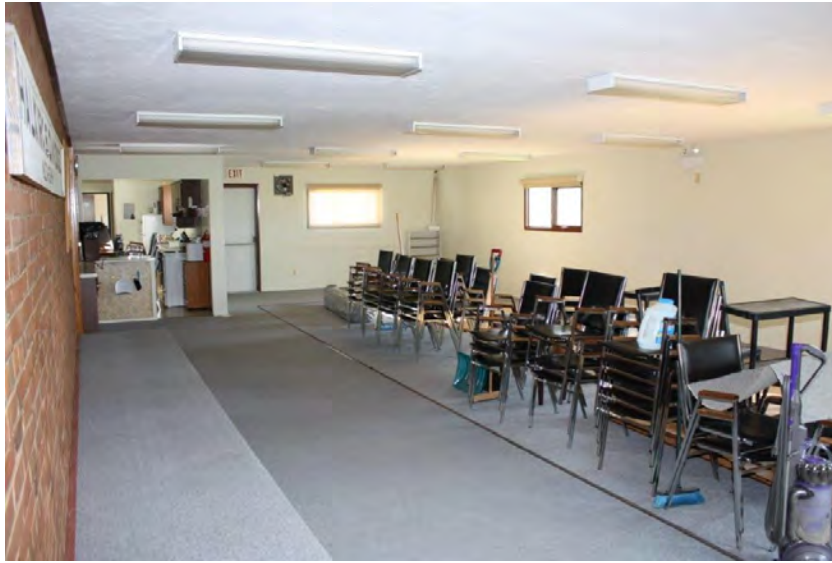
Photograph 7: The east side of the Seniors Center used for storage and floor curling (June 23, 2021).

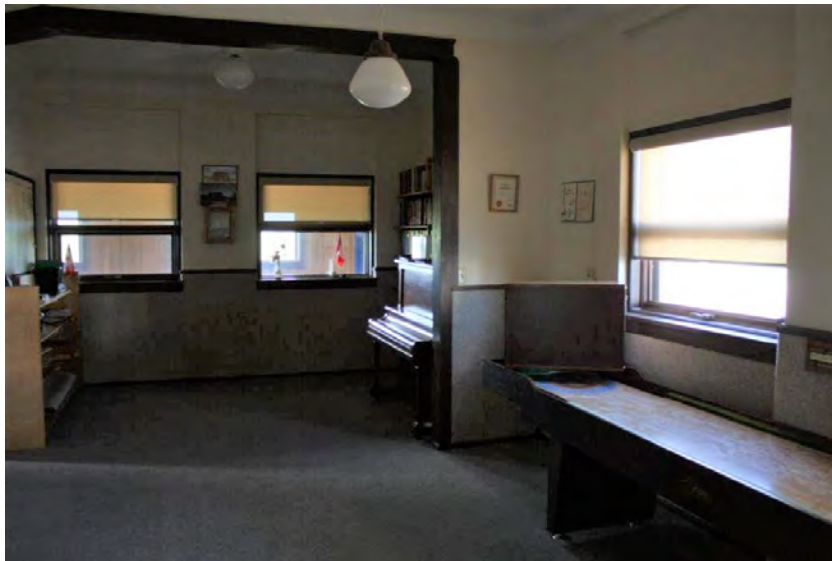
Photograph 8: The west portion of the Seniors Center containing shuffleboard, a piano and the south entrance (June 23, 2021).

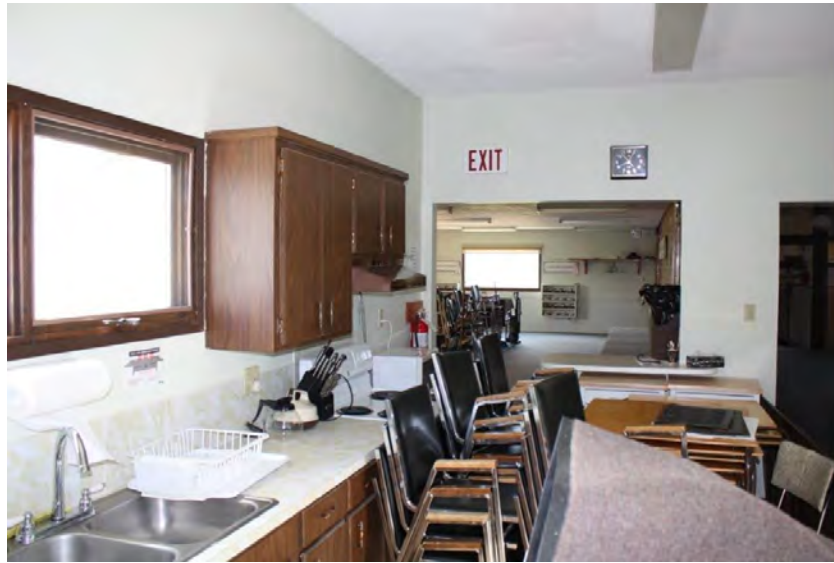
Photograph 9: The kitchen in the north portion of the Seniors Center, south of Village Office (June 23, 2021).

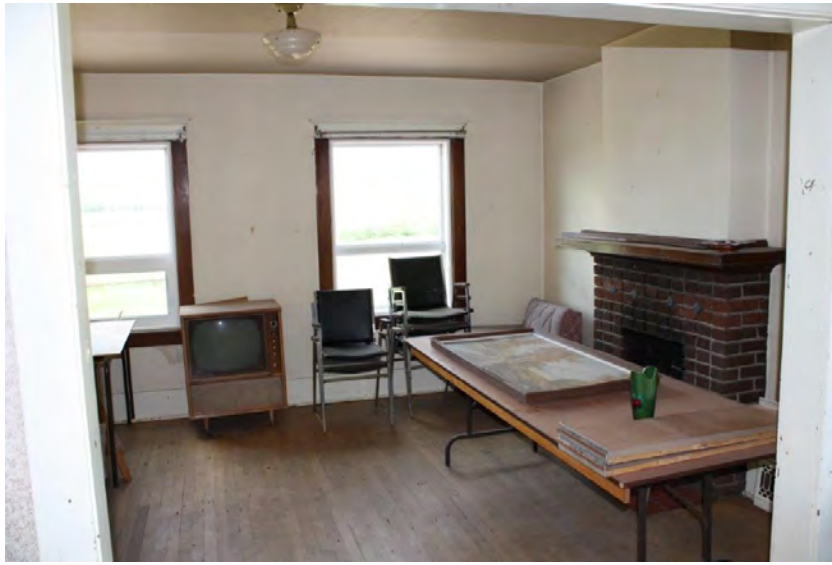
Photograph 11: The living room on the second floor of the Seniors Center (June 23, 2021).

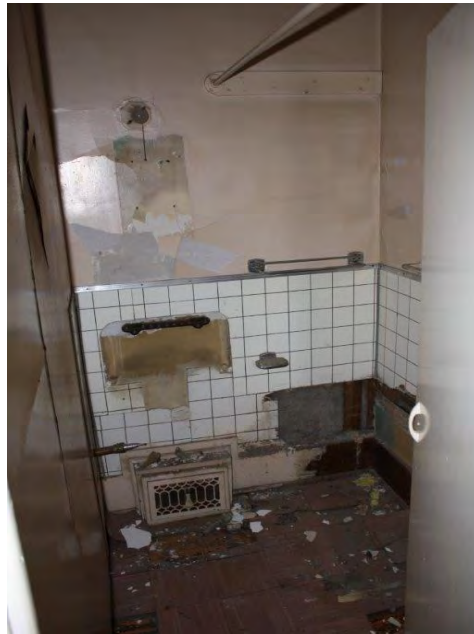
Photograph 13: The former washroom on the second floor of the Seniors Center (June 23, 2021).

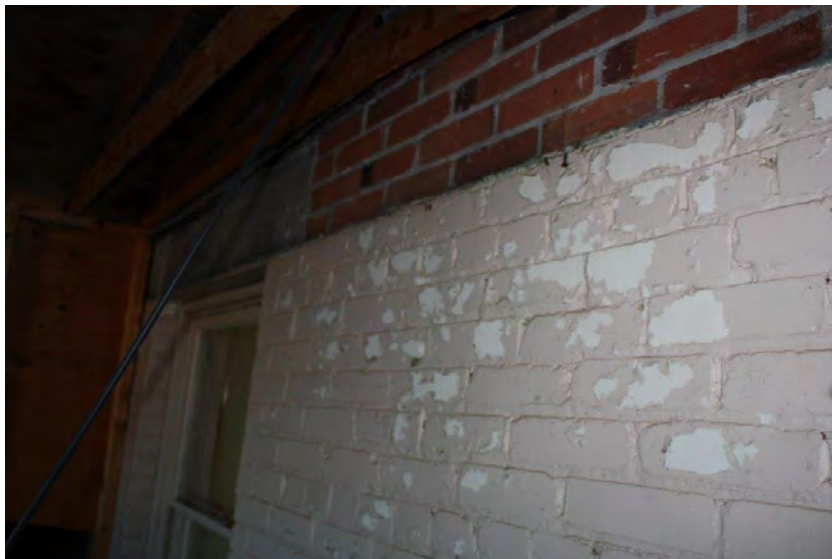
Photograph 14: Layered paint on a former external wall which has since been added on to with the addition of the Village Office (June 23, 2021).

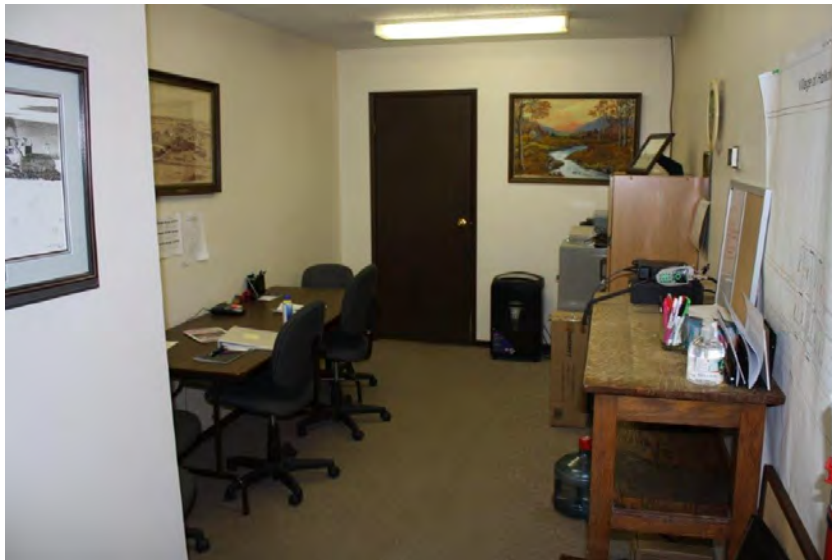
Photograph 16: The back portion of the Village Office (June 23, 2021).

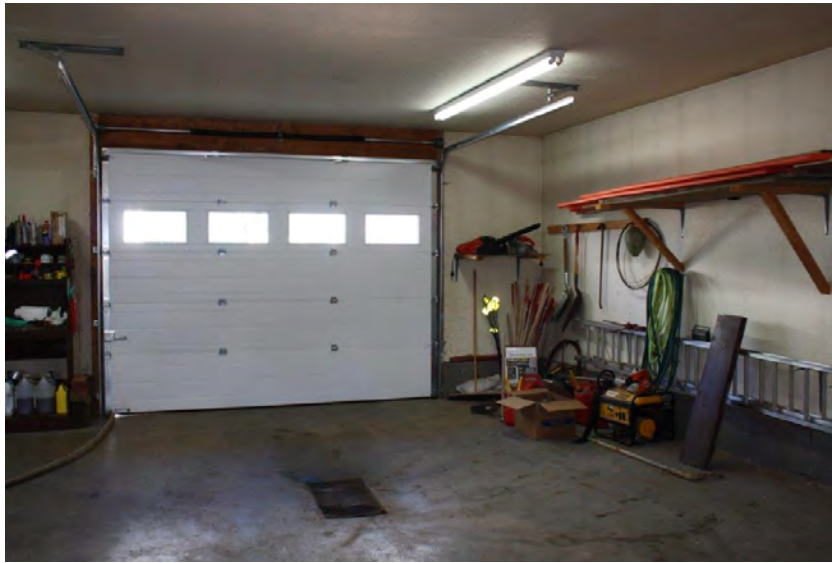
Photograph 17: The west portion of the Public Works shop (June 23, 2021).

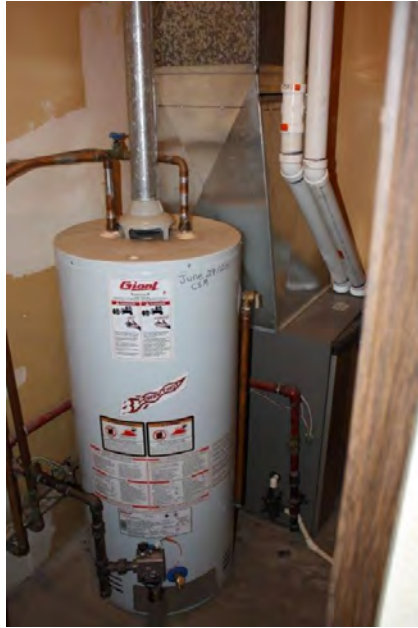
Photograph 19: The mechanical room in the Public Works shop which also services the Village Office (June 23, 2021).

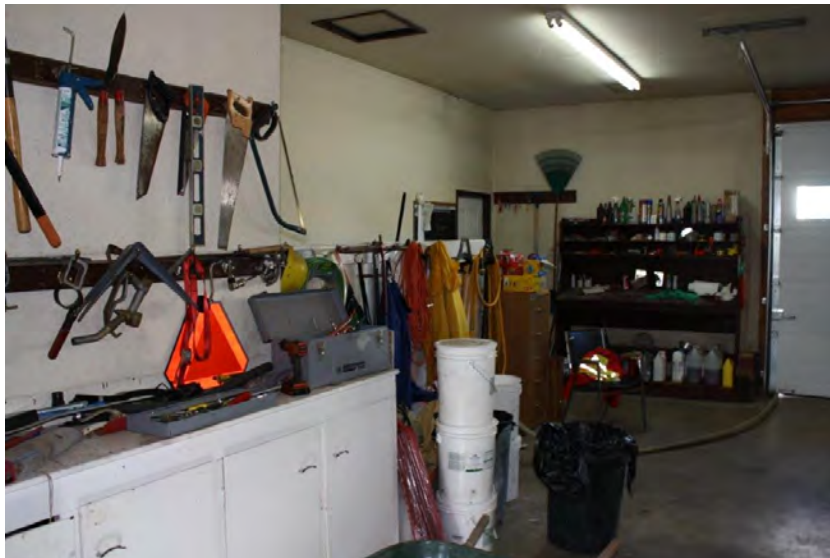
Photograph 20: The south portion of the Public Works shop (June 23, 2021).

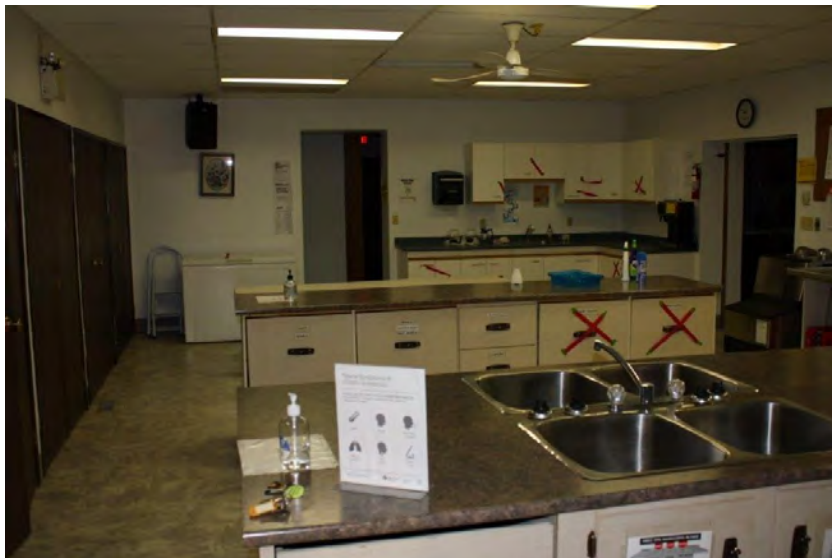
Photograph 22: Looking across the kitchen in the north portion of the Community Hall (June 23, 2021).

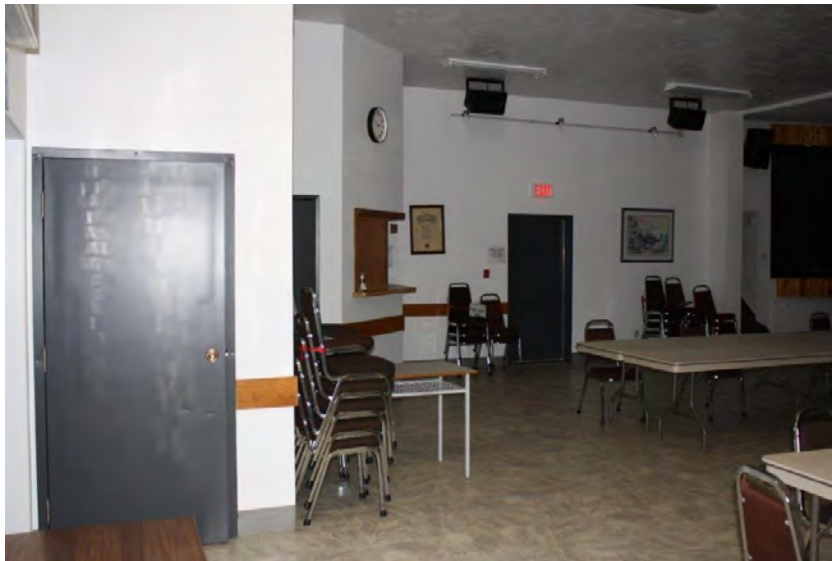
Photograph 24: Looking east over the concession and east side of the hall (June 23, 2021).

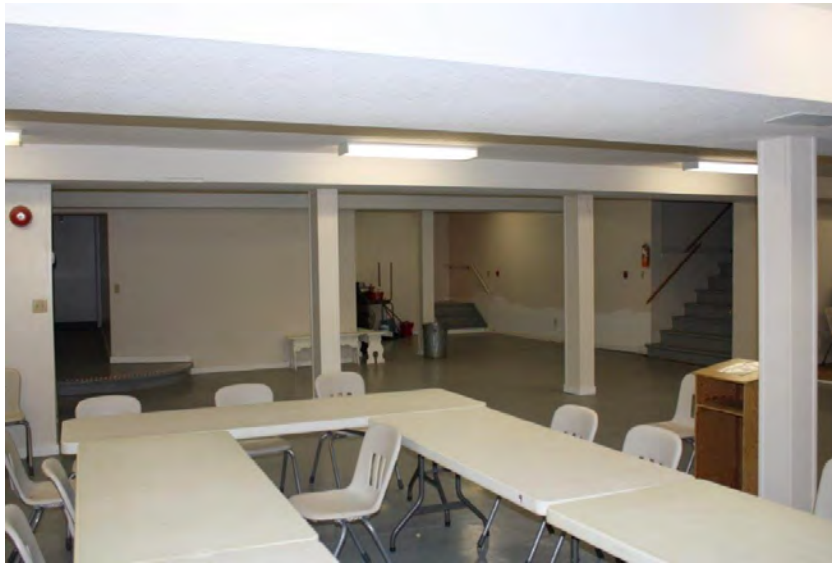
Photograph 27: Looking across the basement in the Community Hall (June 23, 2021).

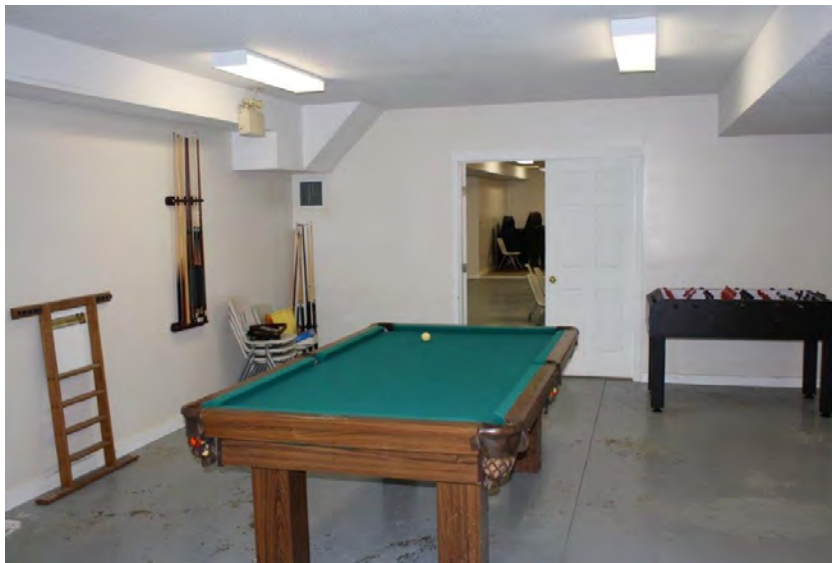
Photograph 28: The games room in the basement of the Community Hall (June 23, 2021).

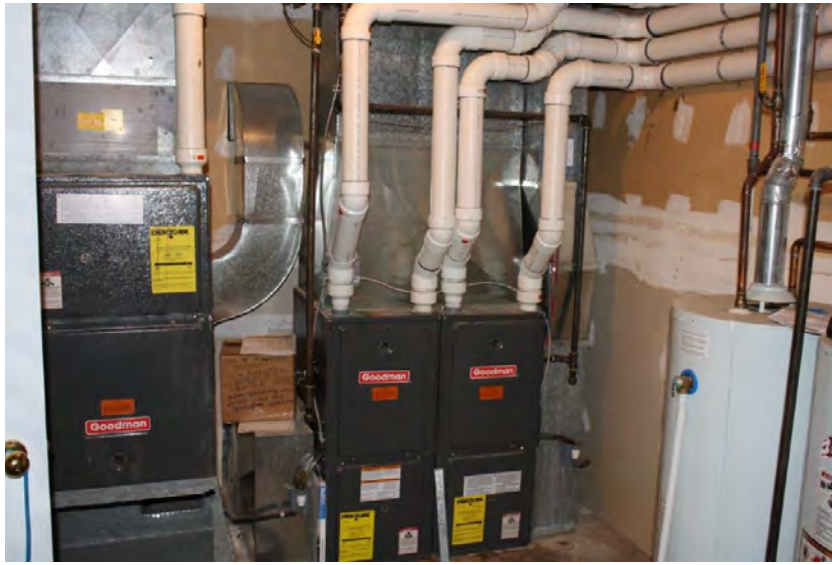
Photograph 29: The mechanical room in the basement of the Community Hall (June 23, 2021).

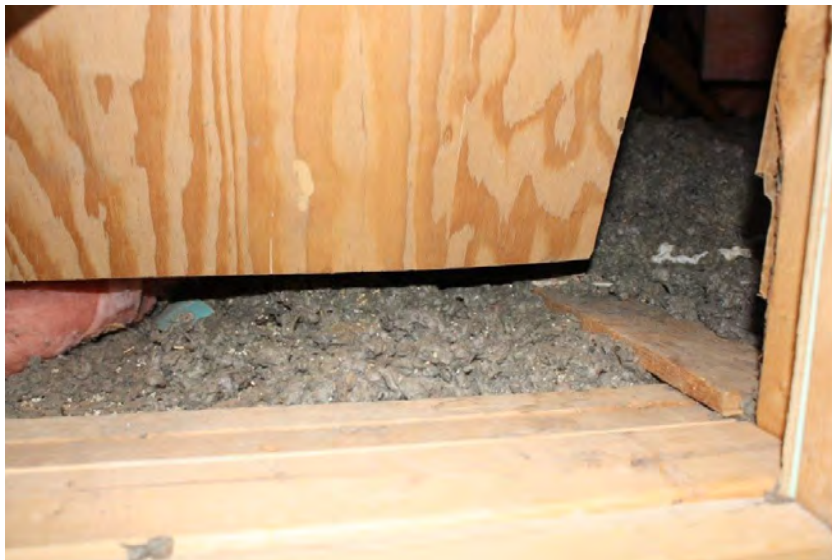
Photograph 30: Insulation in the attic of the Community Hall (June 23, 2021).

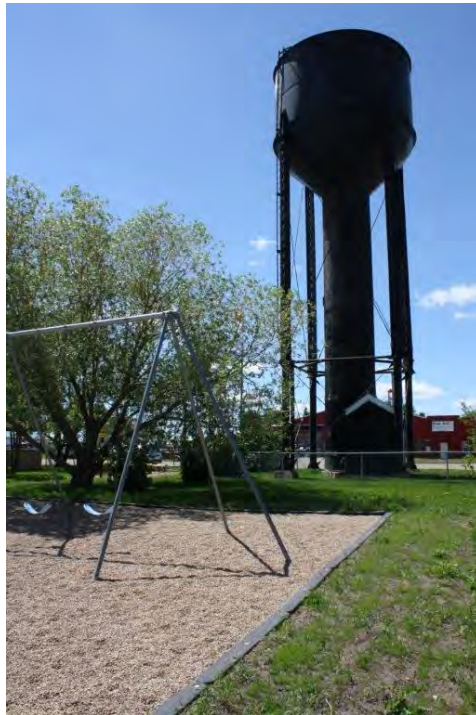
Photograph 33: Looking west across the north side of the Playground toward the Water tower (June 23, 2021).

Phase II ESAs are recommended on the Church, Curling Rink, Berry Street Campground, Community Hall, Water Tower, Playground, Fire Hall and Canada Post and Bank building due to the proximity of offsite fuel USTs. Soil and Groundwater samples be collected and analysed for respective parameters of potential concern based on the adjacent site operations.

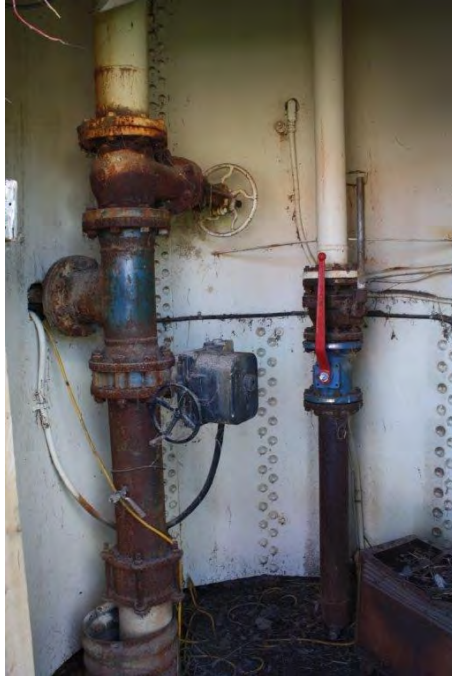
Photograph 35: Piping within the Water Tower (June 23, 2021).

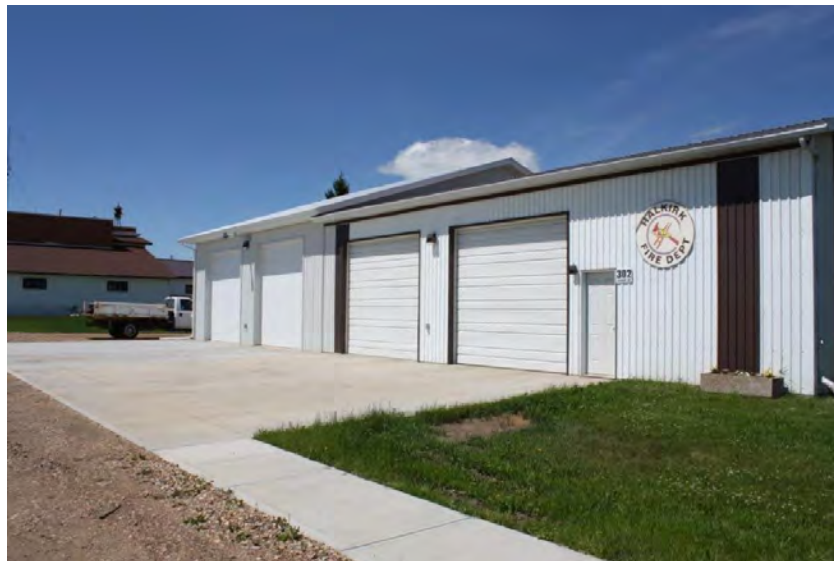
Photograph 36: Looking northwest from Railway Avenue across the front of the Fire Hall (June 23, 2021).

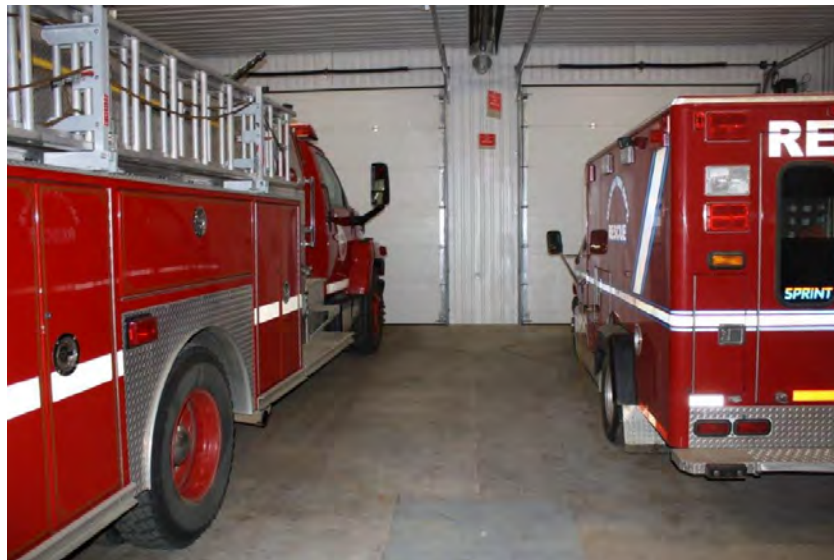
Photograph 38: Looking south in the addition to the Fire Hall on the east side over the drain (June 23, 2021).

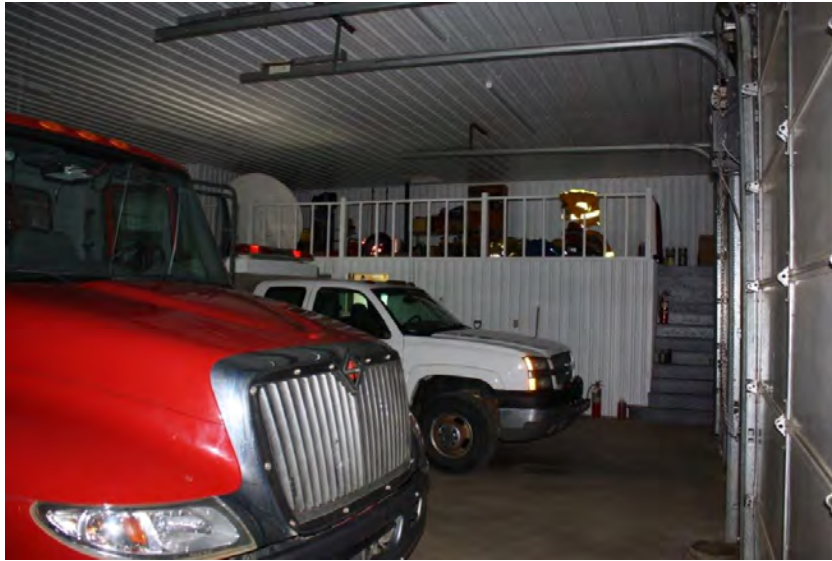
Photograph 39: Looking east across the south side of the original Fire Hall showing parked response vehicles and the mezzanine (June 23, 2021).

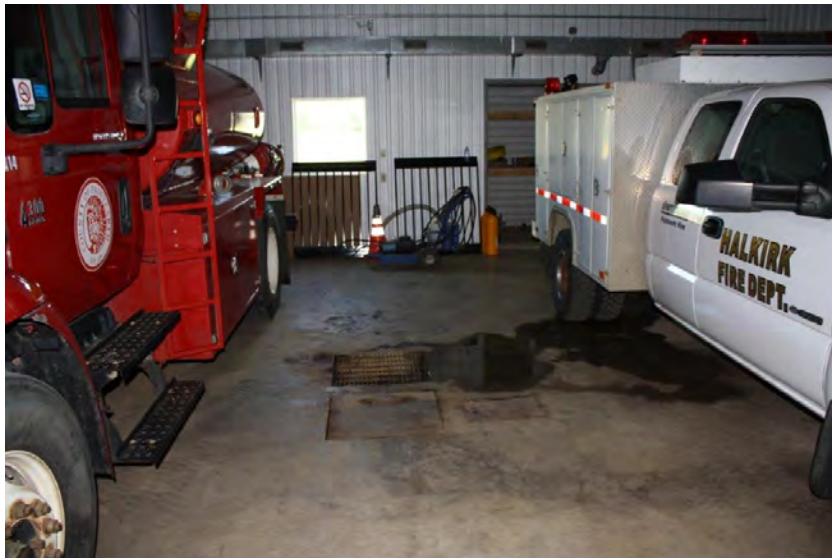
Photograph 40: The drain and sump in the original building at the Fire Hall (June 23, 2021).

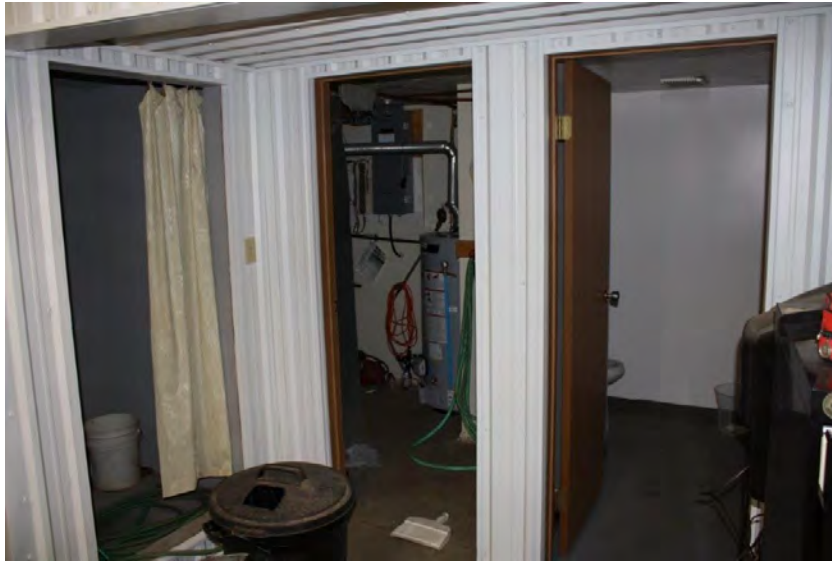
Photograph 41: The showers, mechanical room and lunch room under the mezzanine in the Fire Hall (June 23, 2021).

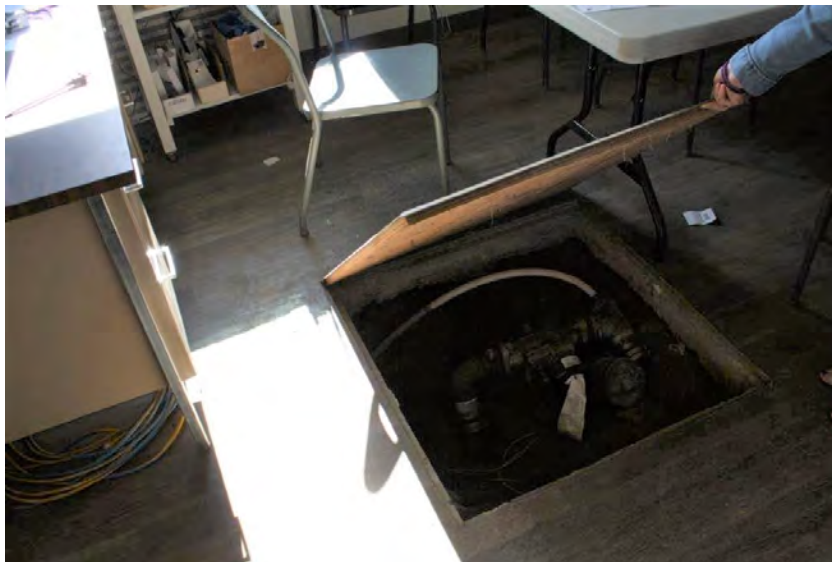
Photograph 42: The septic cleanout in the lunchroom in the Fire Hall (June 23, 2021).

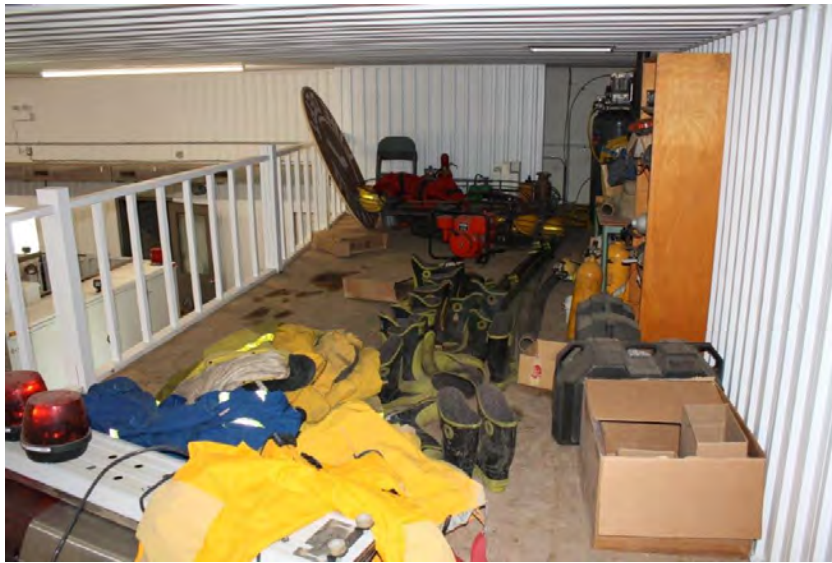
Photograph 43: The mezzanine in the Fire Hall used for storage (June 23, 2021).

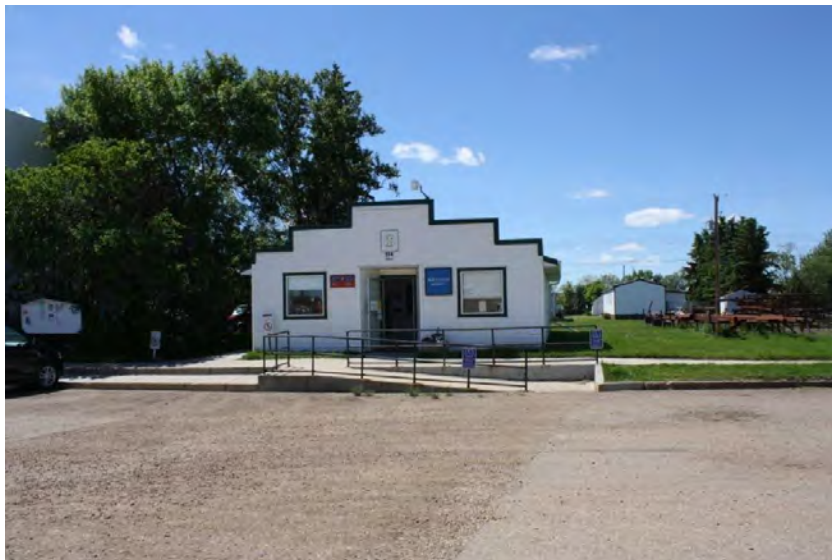
Photograph 44: Looking west across Main Street towards the Canada Post and Bank building (June 23, 2021).
