VILLAGE OF HALKIRK

INFRASTRUCTURE ASSESSMENT AND 10-YEAR CAPITAL PLAN

Date: September 30, 2021
Project Number: 4460-005-00

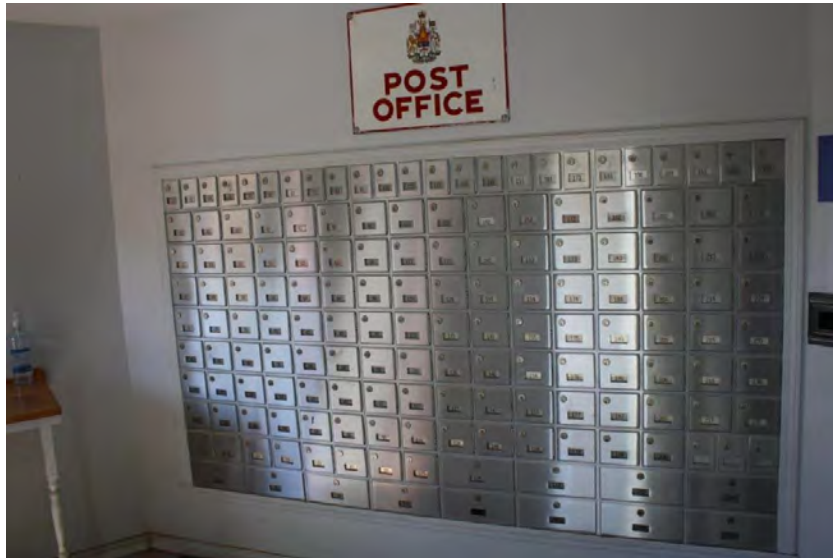
Photograph 45: The mailboxes in the common space on the east side of the Canada Post office (June 23, 2021).

Phase II ESAs are recommended on the Church, Curling Rink, Berry Street Campground, Community Hall, Water Tower, Playground, Fire Hall and Canada Post and Bank building due to the proximity of offsite fuel USTs. Soil and Groundwater samples be collected and analysed for respective parameters of potential concern based on the adjacent site operations.

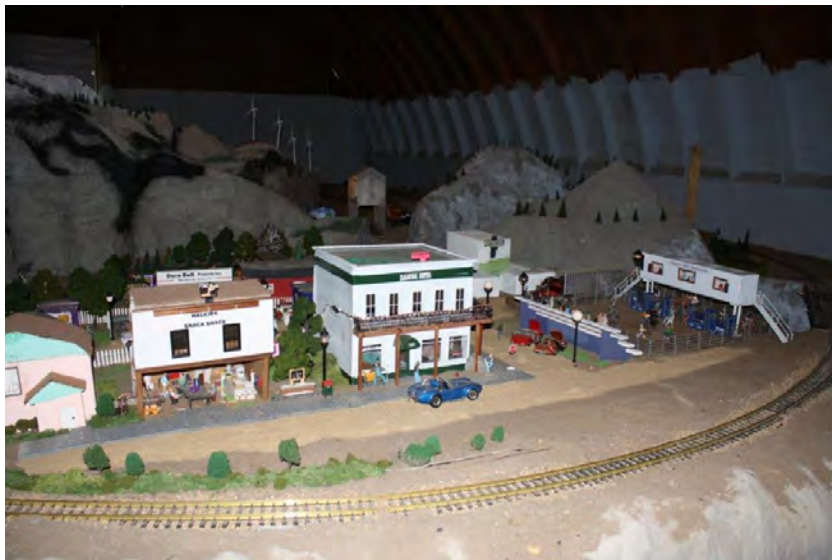
Photograph 4: A miniature display of the Village of Halkirk within the Mini Arena (June 23, 2021).

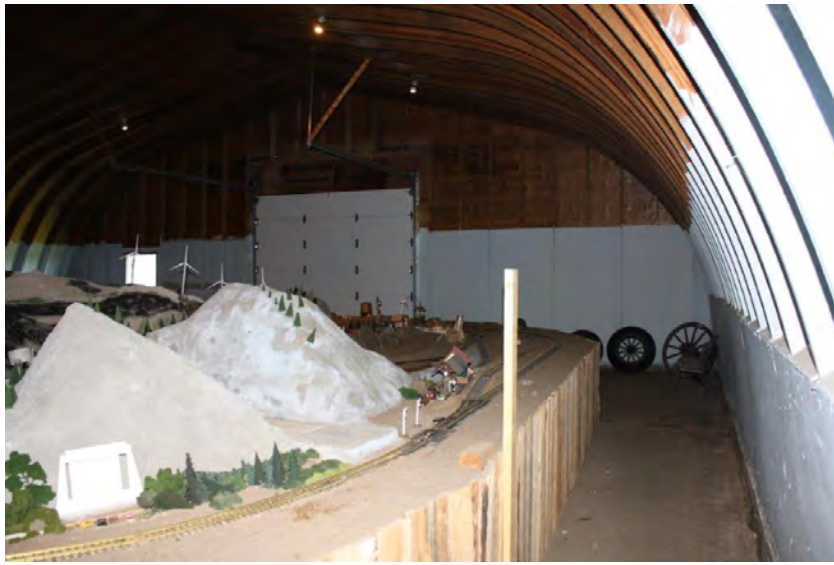
Photograph 5: looking north along the east side of the Mini Arena showing the model train display (June 23, 2021).

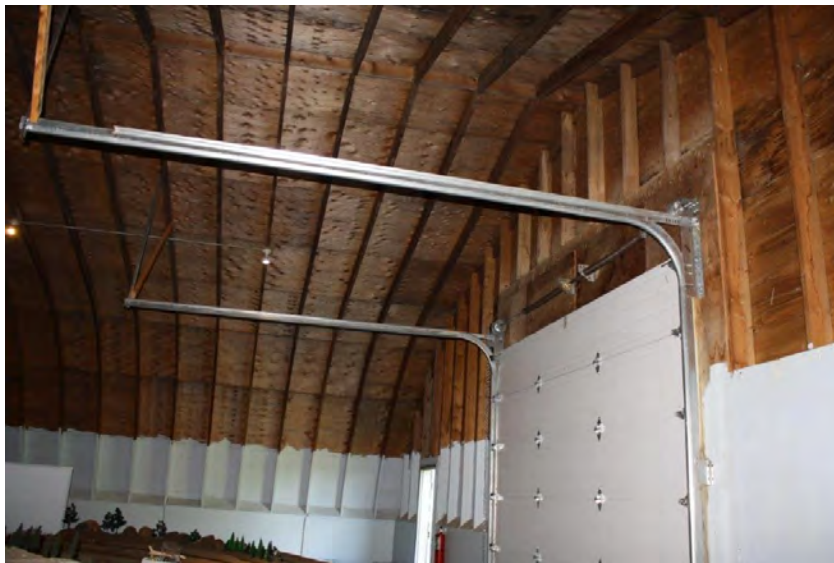
Photograph 6: The uninsulated ceiling and overhead door on the north portion of the Mini Arena (June 23, 2021).

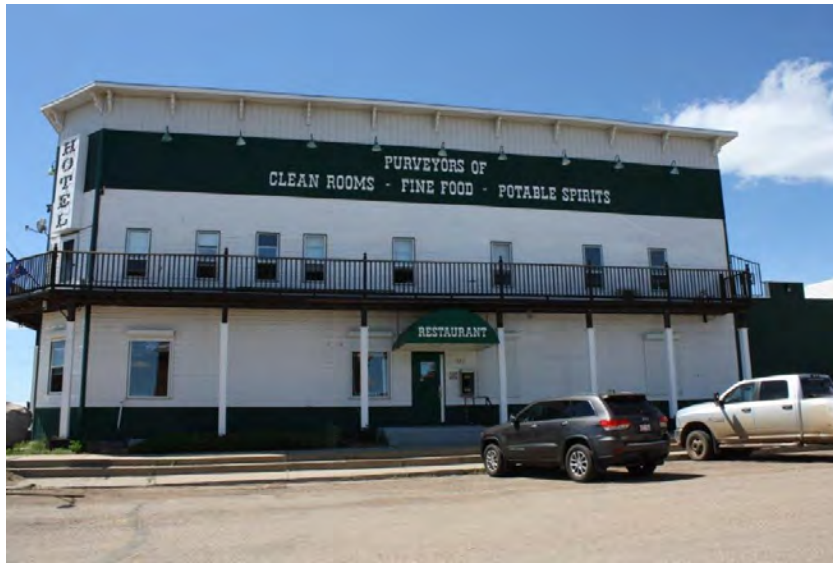
Photograph 1: Looking east at the Halkirk Hotel from Main Street (June 23, 2021).

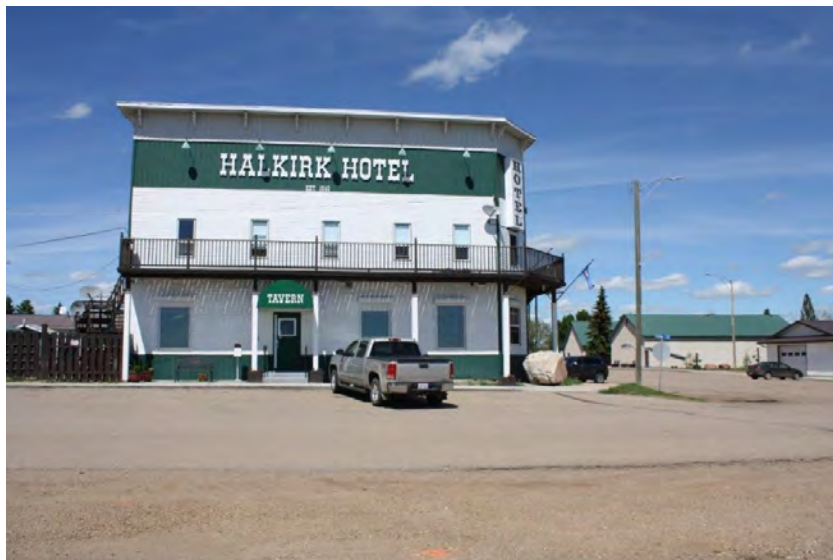
Photograph 2: Looking north at the Halkirk Hotel from the south side of Railway Avenue (June 23, 2021).

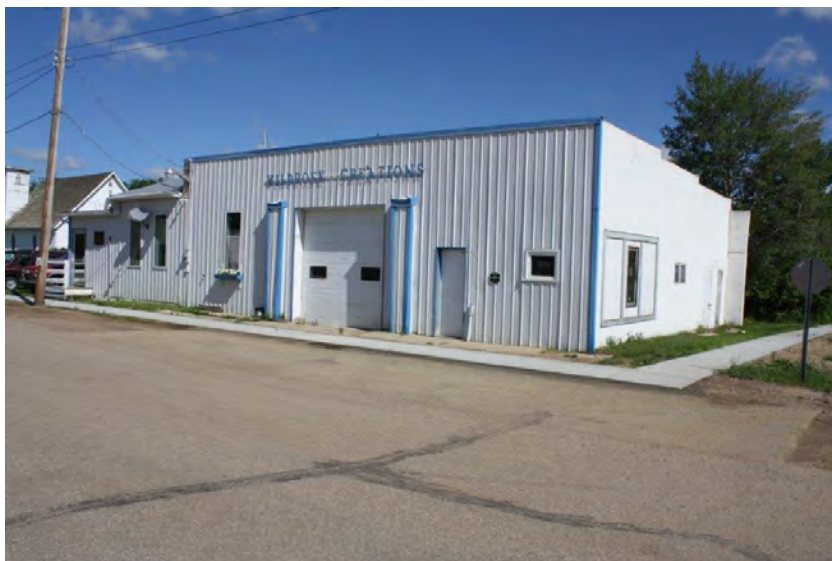
Photograph 3: Former Halkirk Corner Service site with reported Underground Storage Tanks (USTs) at the intersection of Main Street and Alberta Avenue (June 23, 2021).

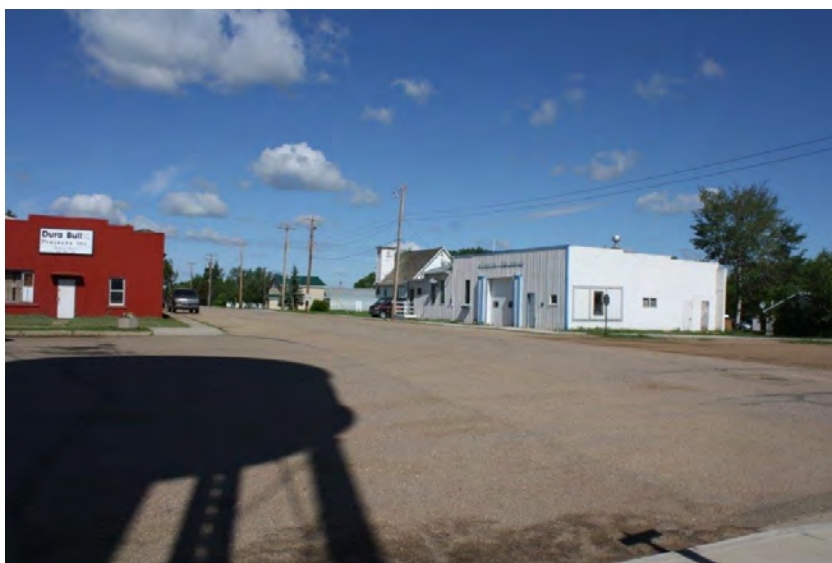
Photograph 4: Looking across the Main Street and Alberta Avenue intersection showing the Former Halkirk Corner Service and Dura Bull (June 23, 2021).

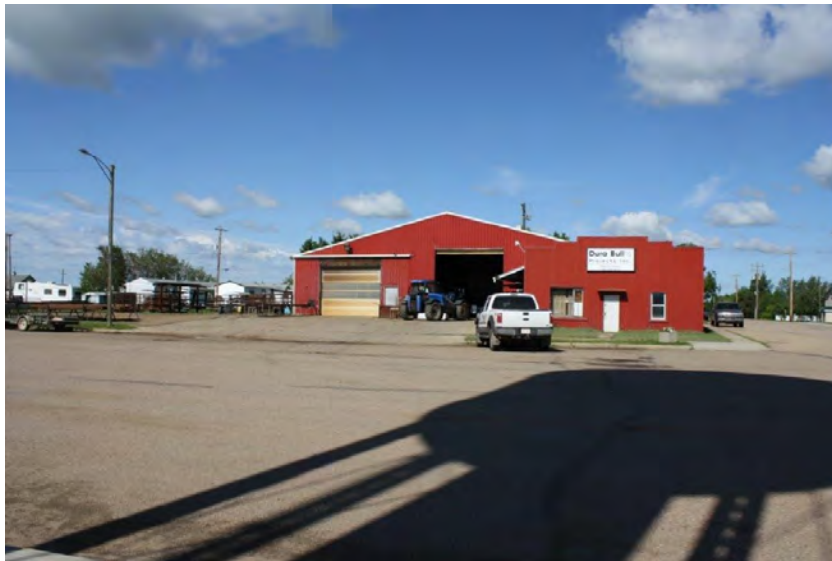
Photograph 5: Looking west across Main Street, south of Alberta Avenue at Dura Bull, a site with reported USTs in the 1960's (June 23, 2021).

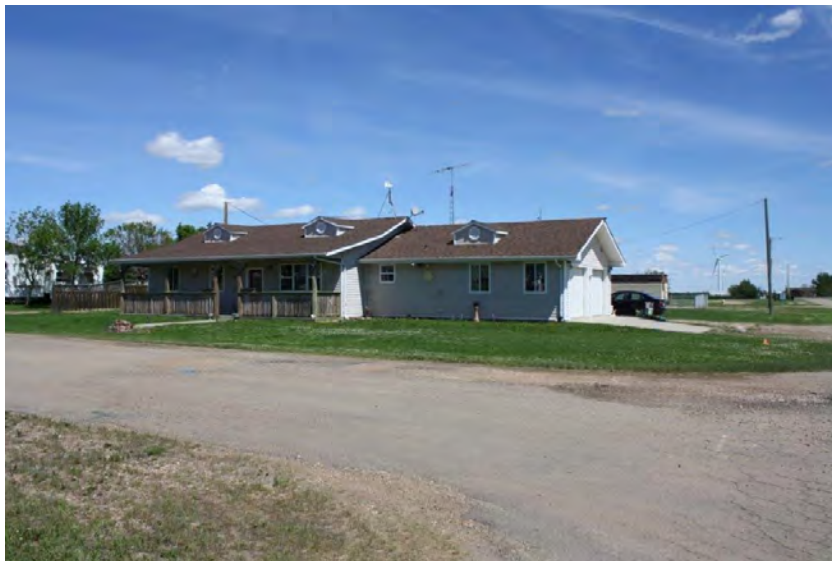
Photograph 6: Looking east over Berry Street, North of Railway Avenue at the residential development east of the Fire Hall which was formerly had USTs (June 23, 2021).
