VILLAGE OF HALKIRK

INFRASTRUCTURE ASSESSMENT AND 10-YEAR CAPITAL PLAN

Date: September 30, 2021
Project Number: 4460-005-00

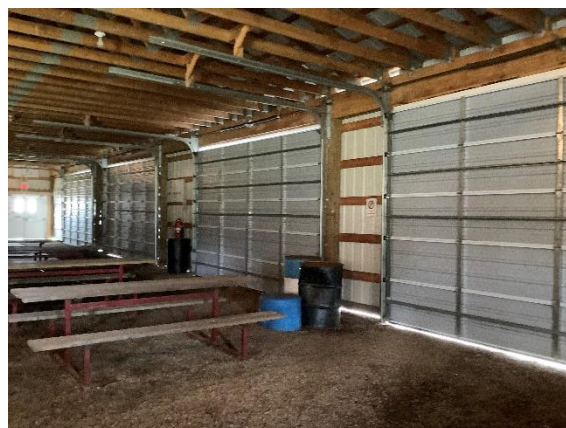
Figure 2.11: Pole Shed Interior

A total cost of \$11,500 of deficiencies were noted to be completed in the next ten years. A summary of the deficiencies are as follows:

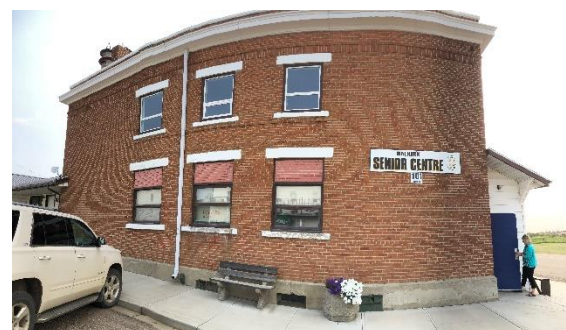
Figure 2.12: Senior Centre Exterior

A total cost of \$288,500 of deficiencies were noted to be completed in the next ten years. A summary of the deficiencies is as follows:

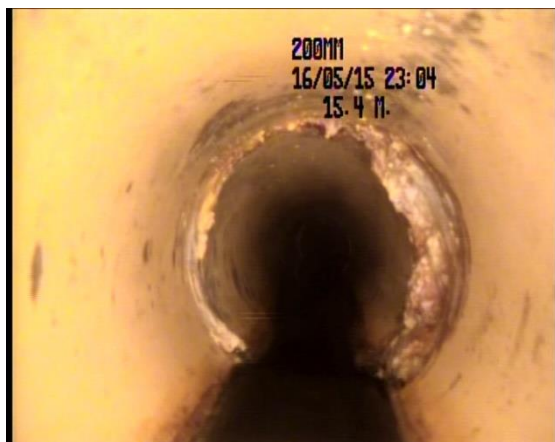
Figure 3.2: Typical Mineral

Based on the criteria, a point system was developed. Sanitary mains in better condition scored higher. In order to rank the mains, a score between 0-5 was given for each category, along with a weighted percentage. Example photographs from previous video inspections of the various defects follow in **Figures 3.2 to 3.6**. A summary of the rating system is shown in **Table 3.7**.

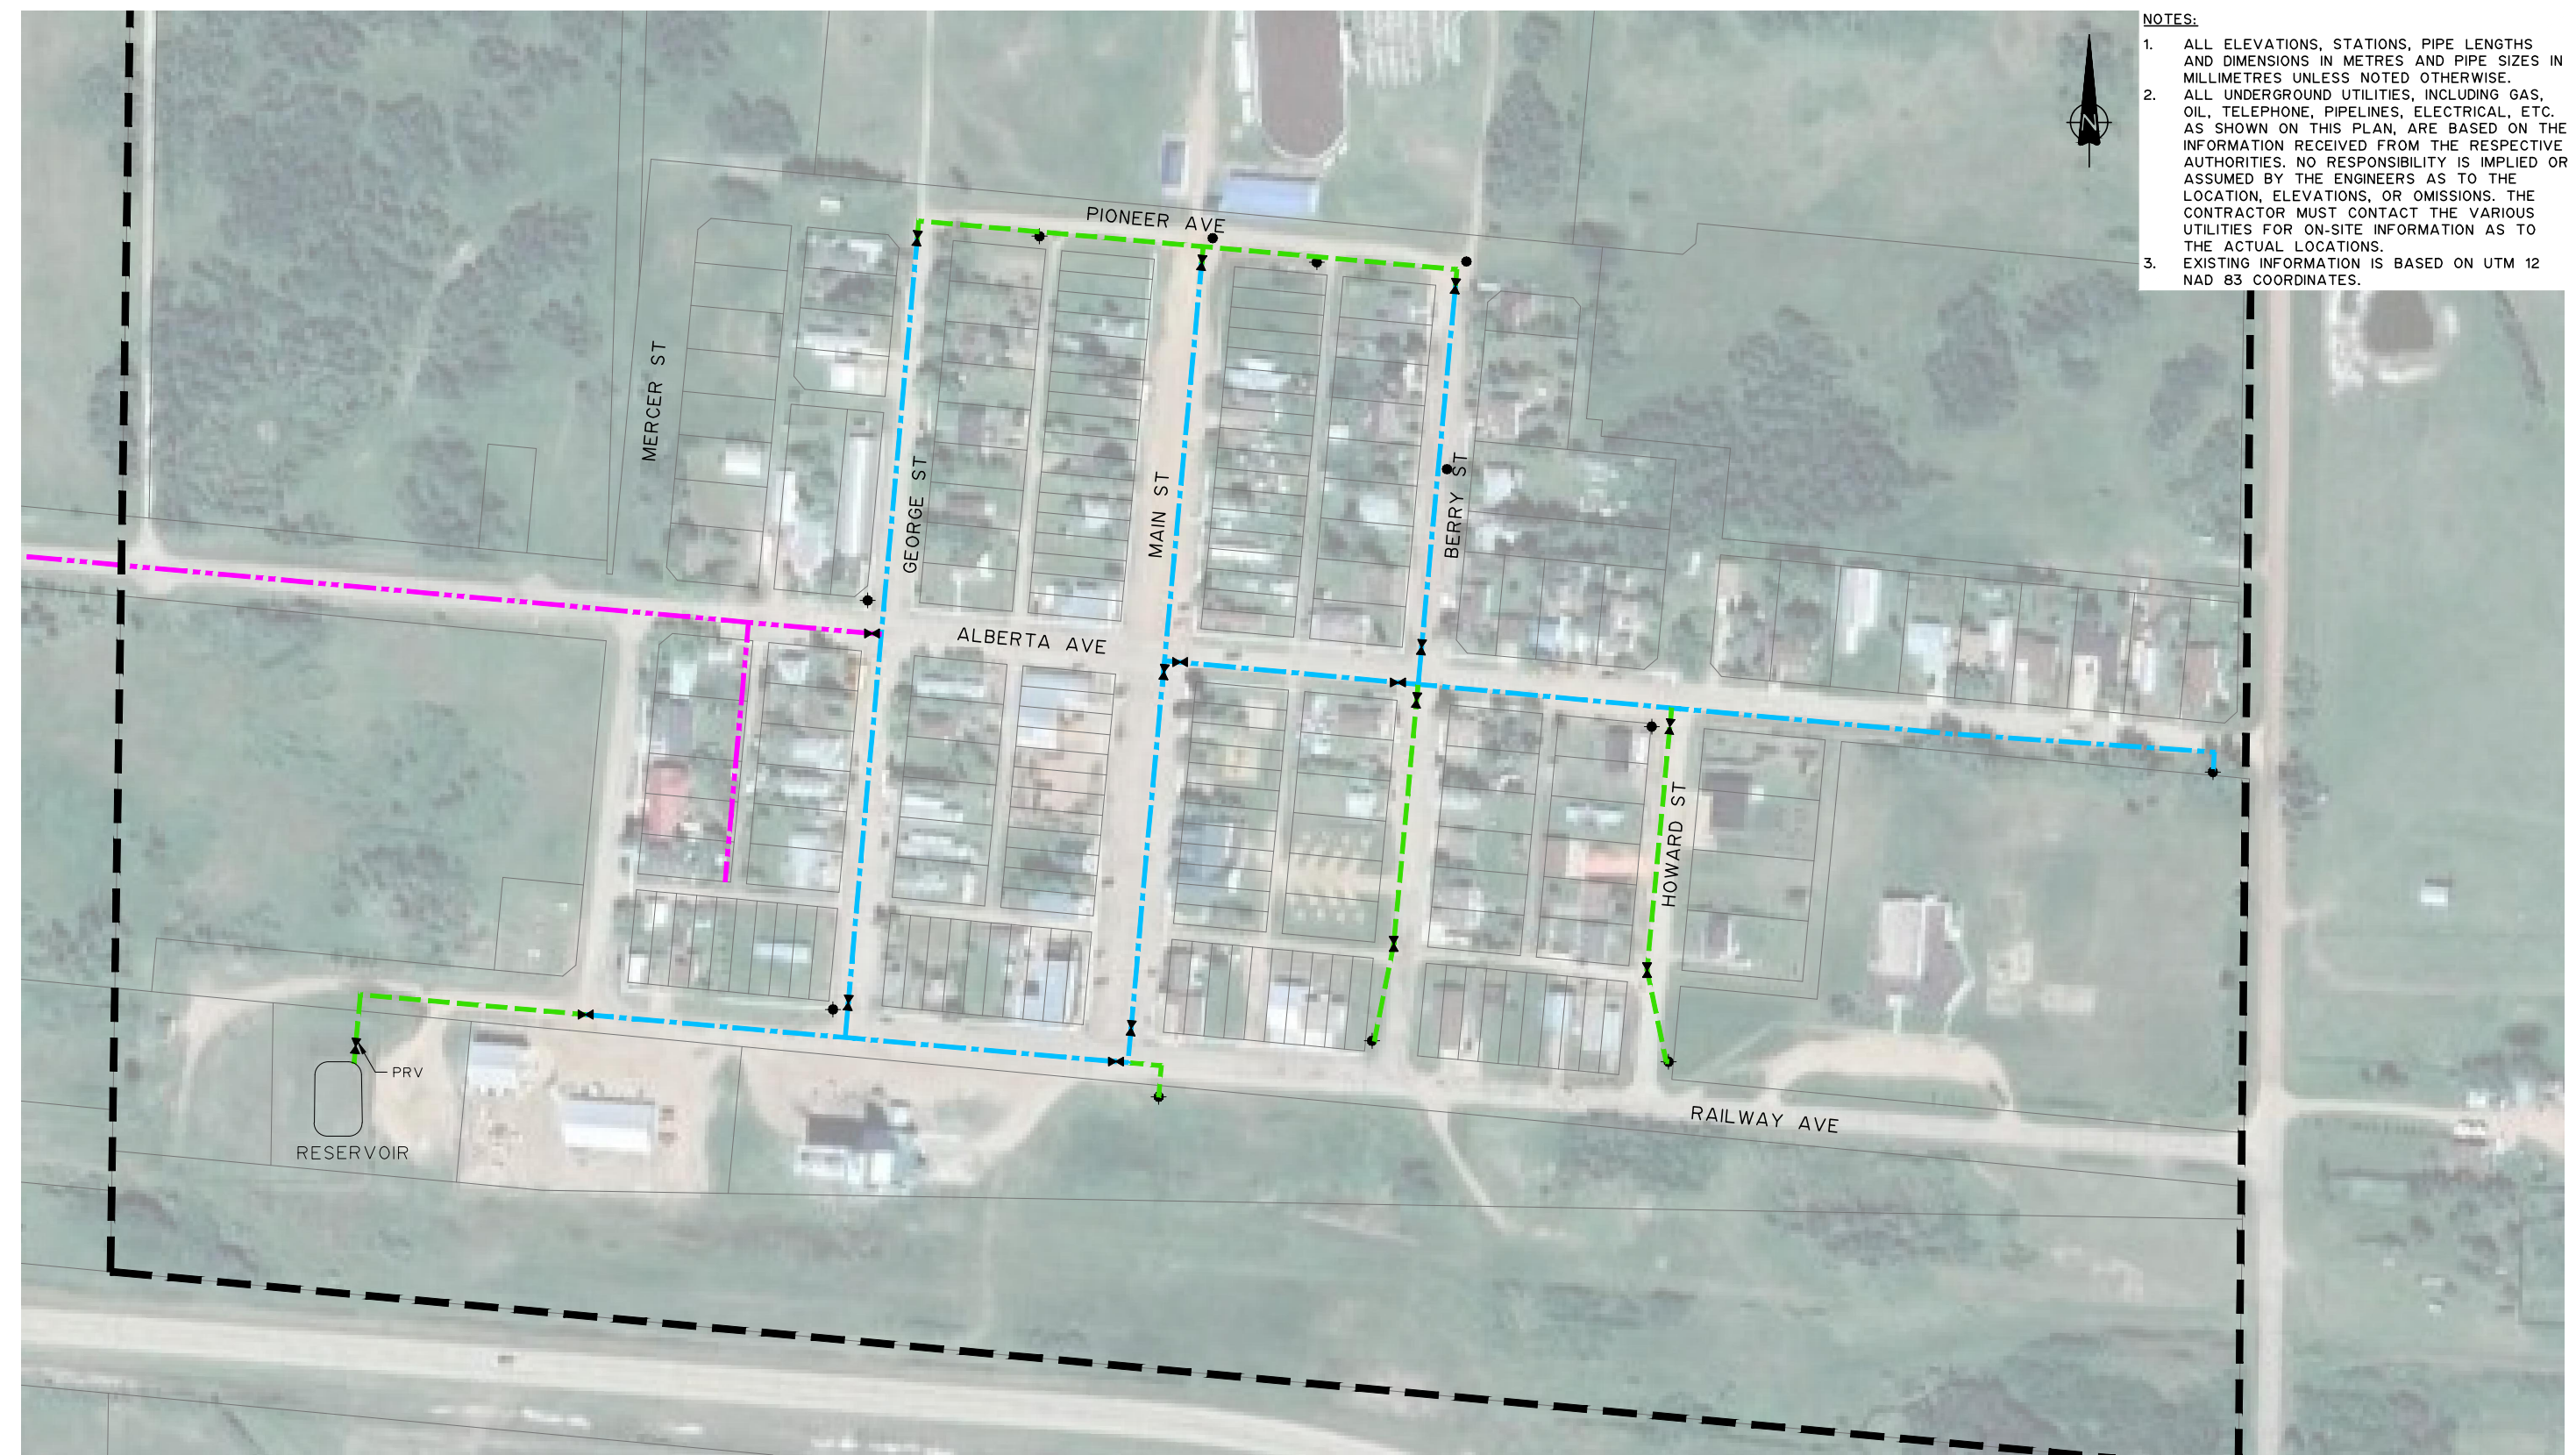
SCALE: 1:2500	DATE: SEPT 2021	JOB: 4460-005-00	DRAWING: 3.1
---------------	-----------------	------------------	--------------

VILLAGE OF HALKIRK
INFRASTRUCTURE ASSESSMENT
EXISTING WATER DISTRIBUTION SYSTEM

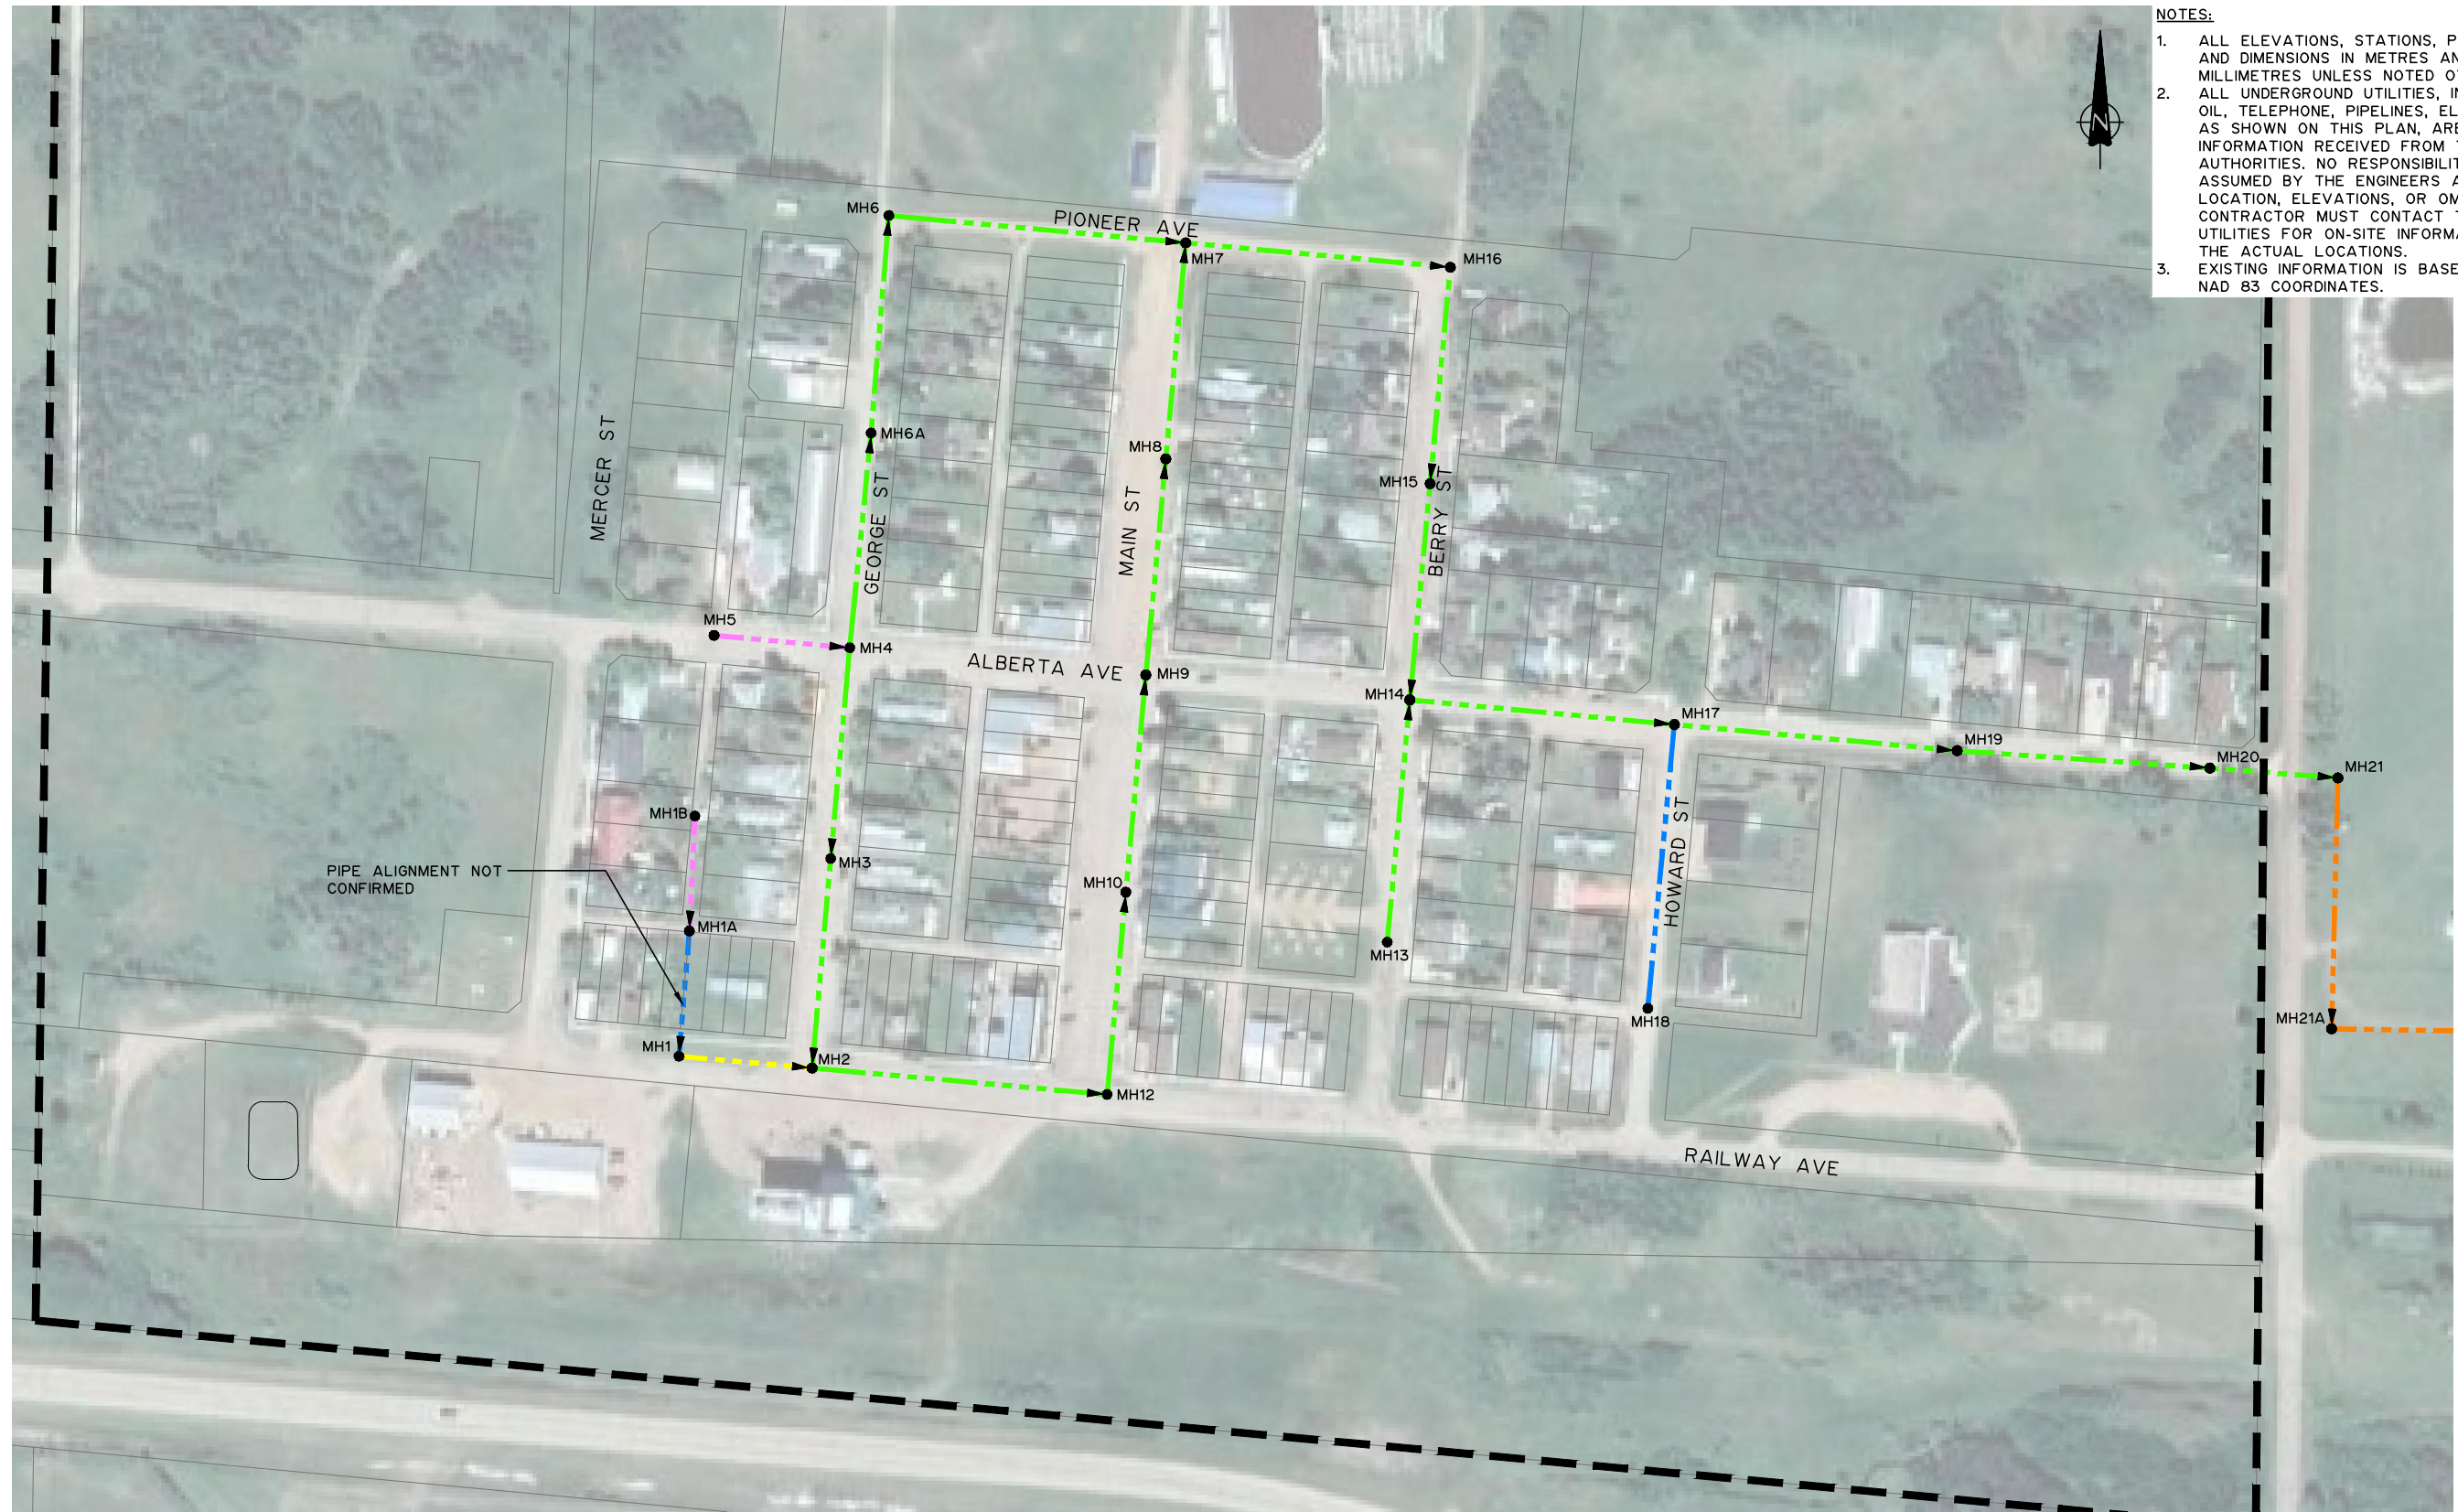
SCALE: 1:2500	DATE: SEPT 2021	JOB: 4460-005-00	DRAWING: 3.4
---------------	-----------------	------------------	--------------

VILLAGE OF HALKIRK
 INFRASTRUCTURE ASSESSMENT
 EXISTING SANITARY COLLECTION SYSTEM

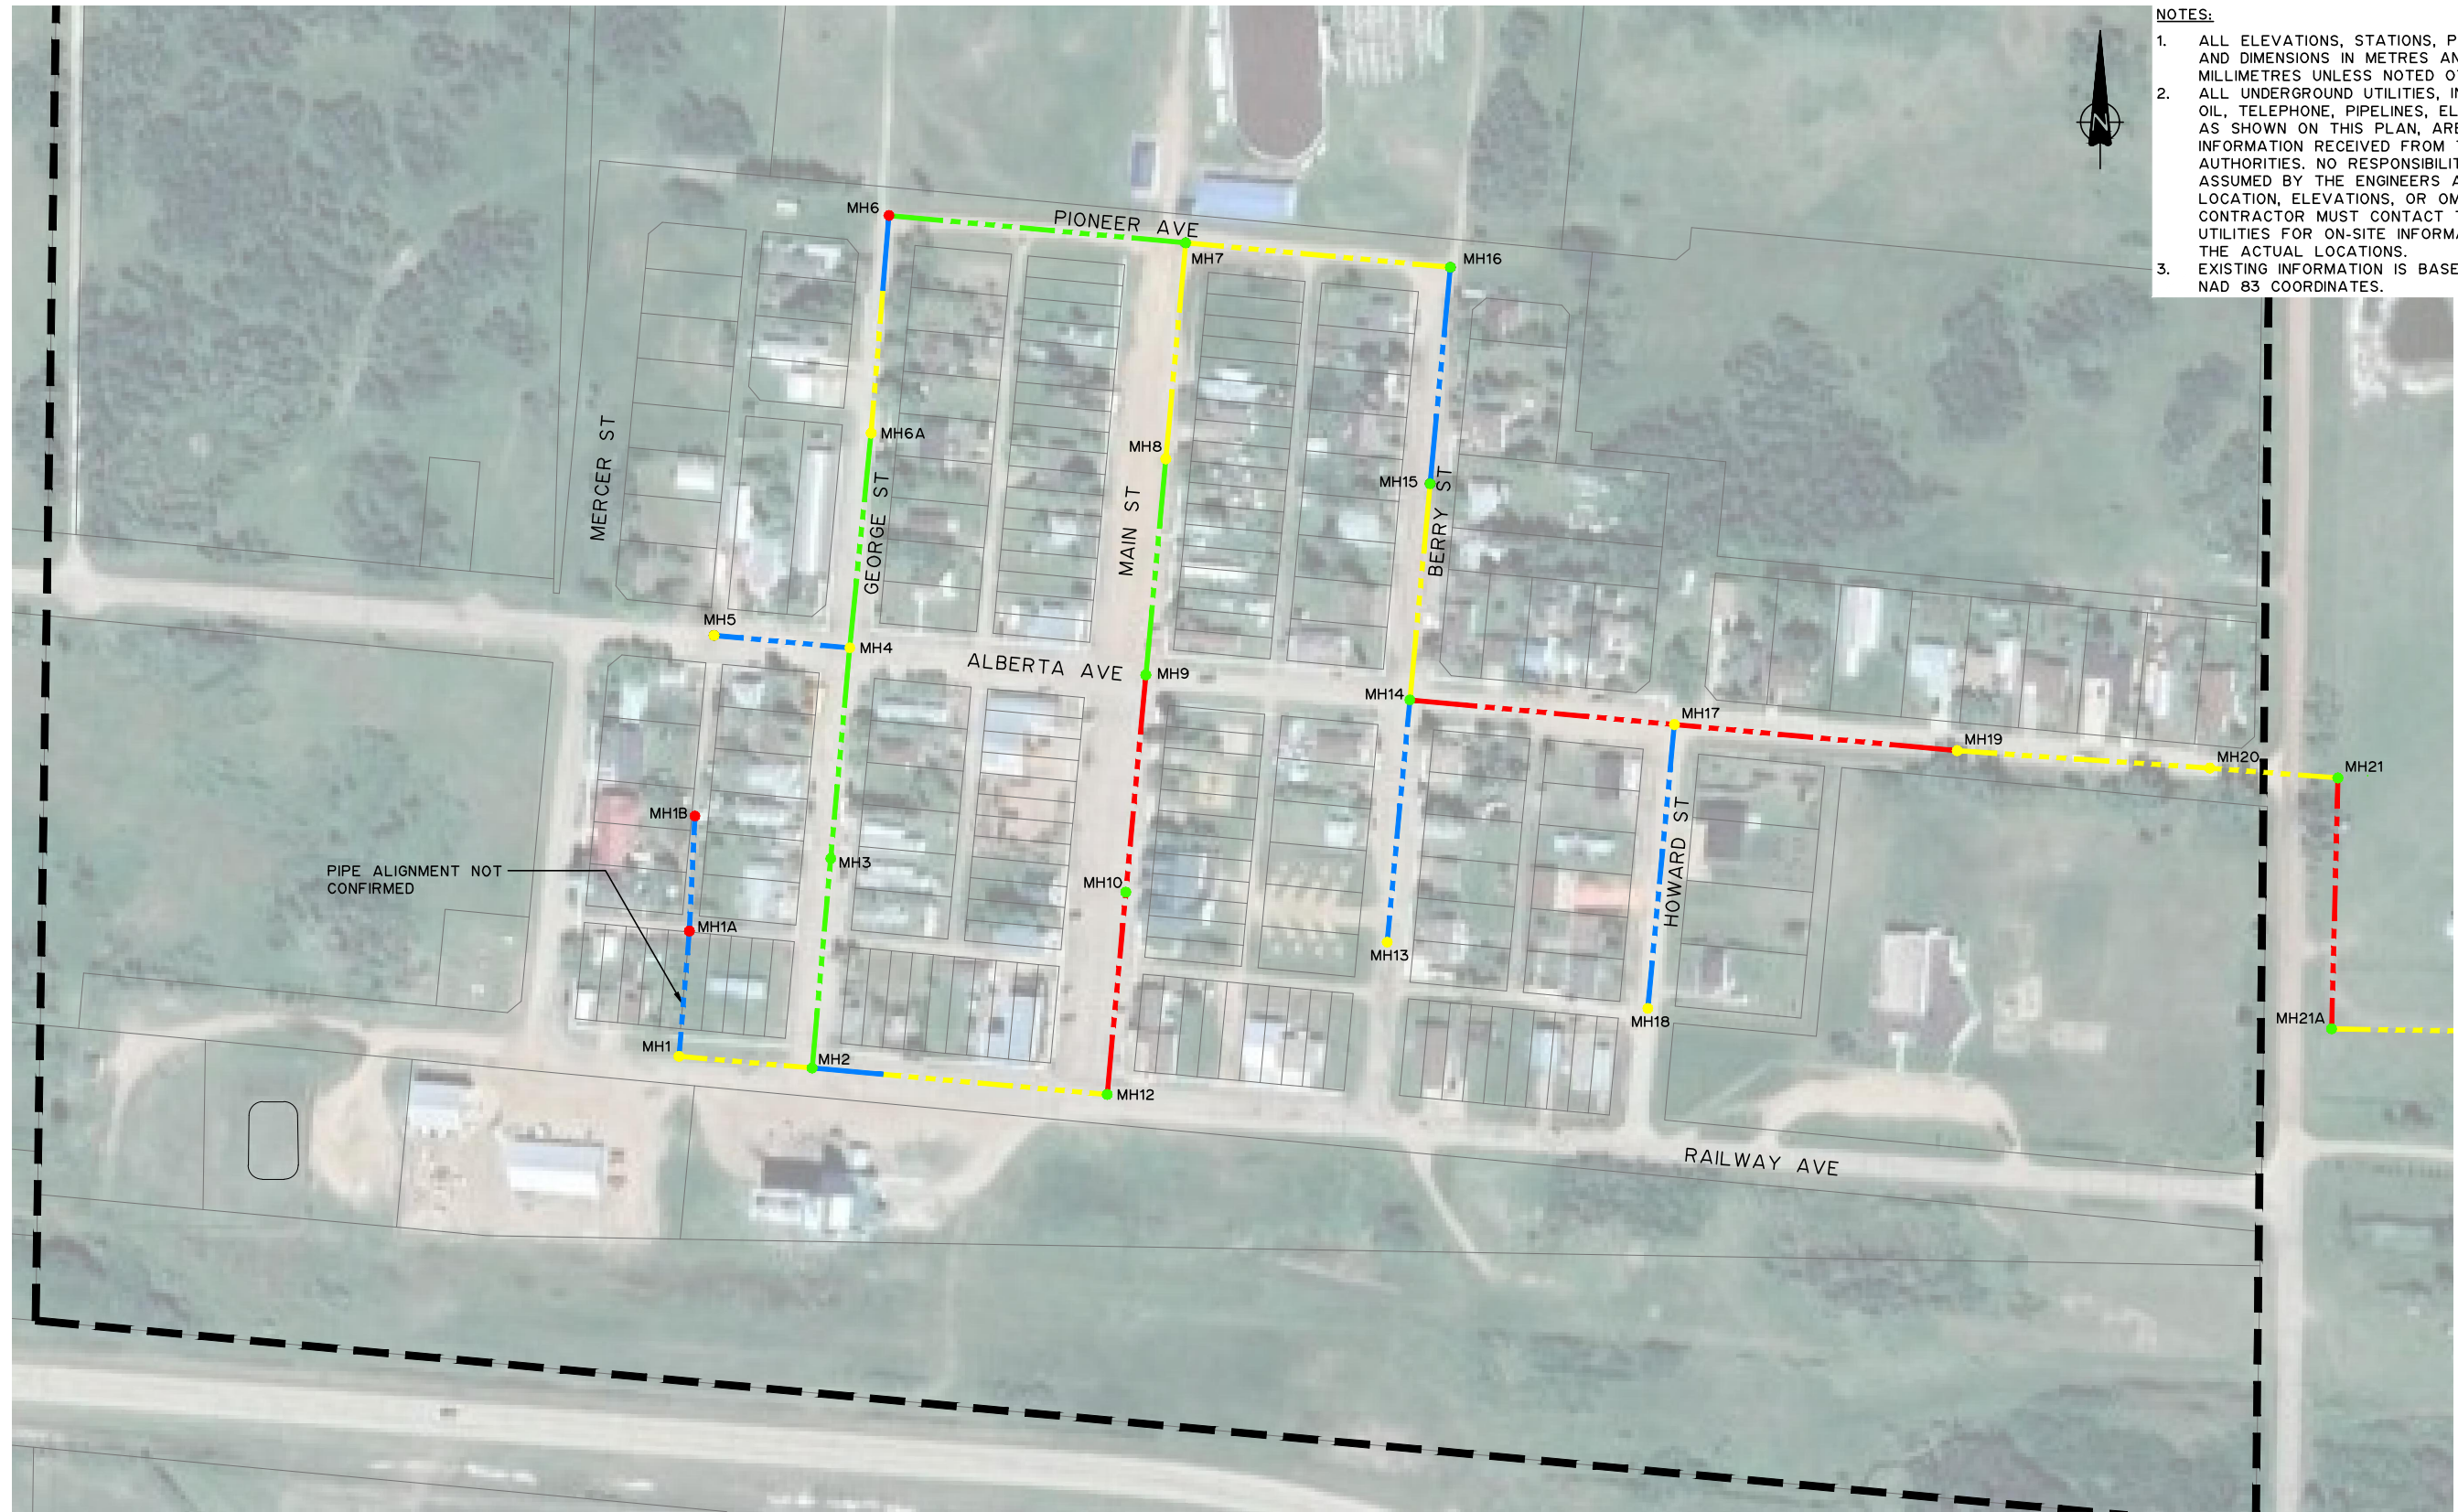
SCALE: 1:2500	DATE: SEPT 2021	JOB: 4460-005-00	DRAWING: 3.5
---------------	-----------------	------------------	--------------

VILLAGE OF HALKIRK
 INFRASTRUCTURE ASSESSMENT
 EXISTING SANITARY COLLECTION SYSTEM -
 PIPE CONDITION

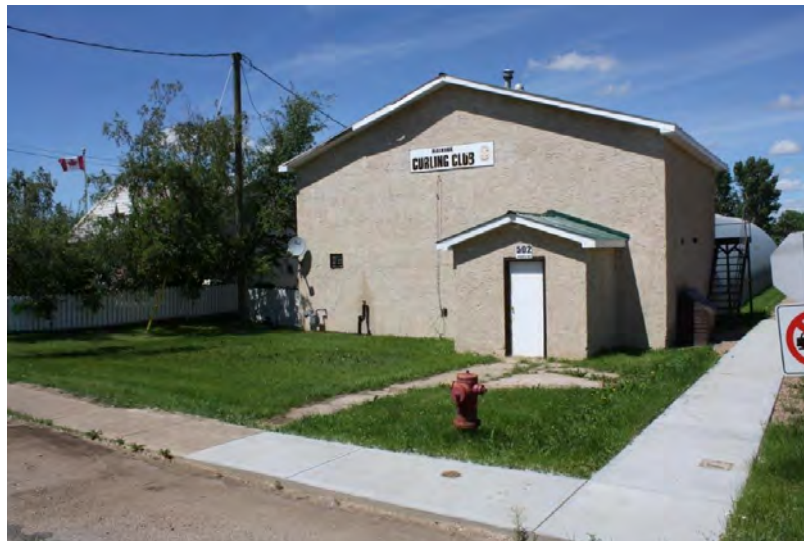
Photograph 4: Looking north at the Curling Rink from Alberta Avenue (June 23, 2021).

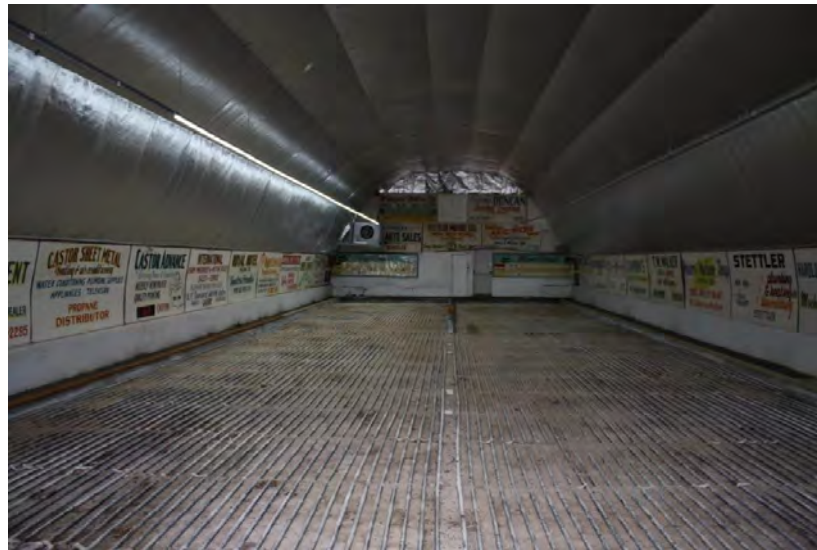
Photograph 9: Looking west over the ice sheets (June 23, 2021).

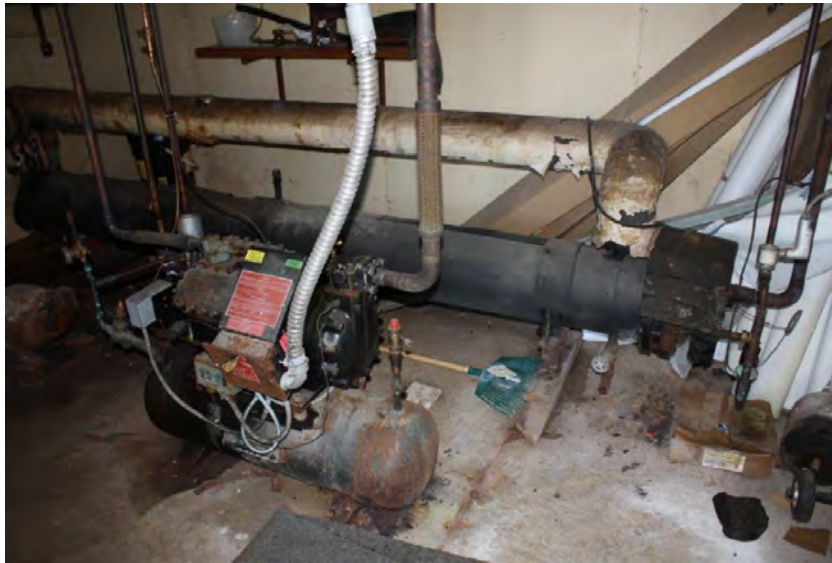
Photograph 13: Components of the artificial ice system (June 23, 2021).

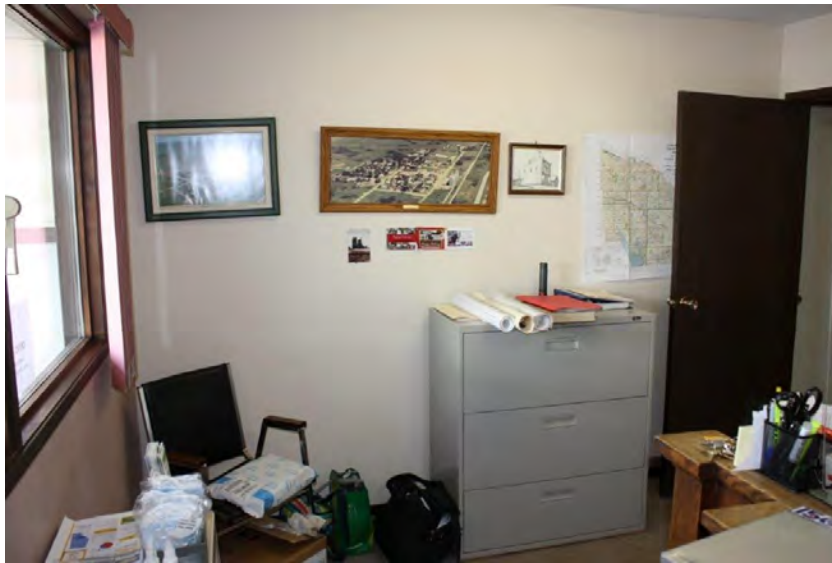
Photograph 15: The front portion of the Village Office (June 23, 2021).

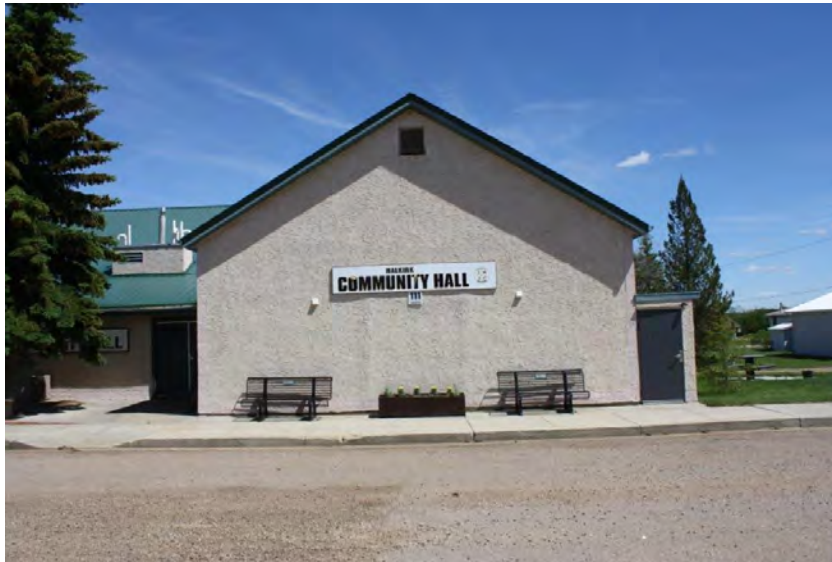
Photograph 21: Looking east across Main Street towards Community Hall (June 23, 2021).

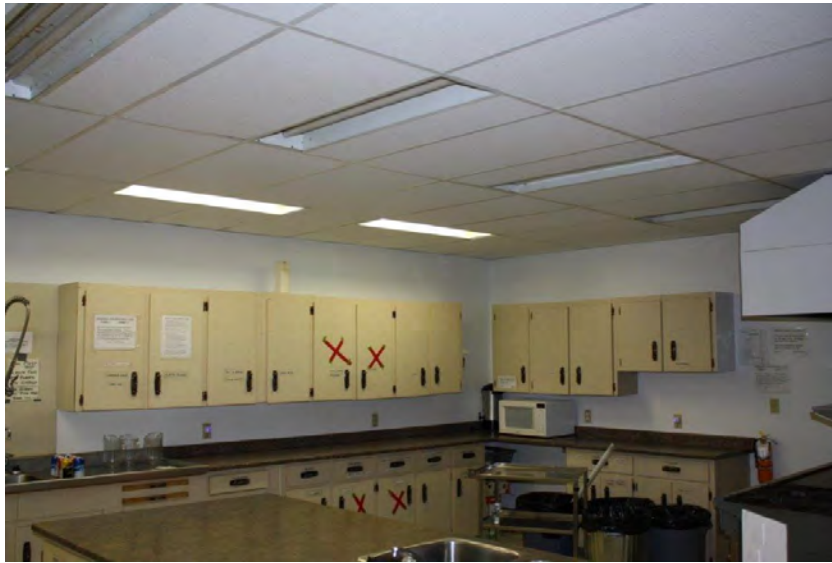
Photograph 23: Additional cabinets and finishing within the kitchen (June 23, 2021).

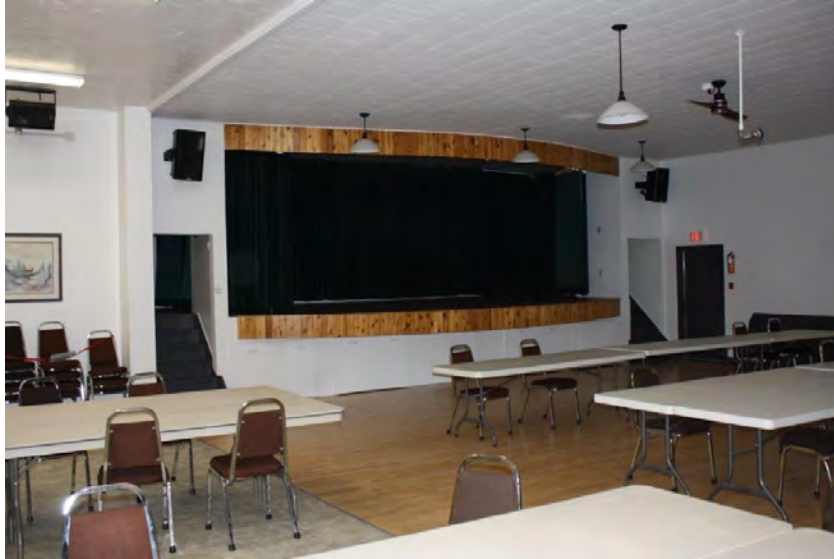
Photograph 25: The stage in the southeast portion of the Community Hall (June 23, 2021).

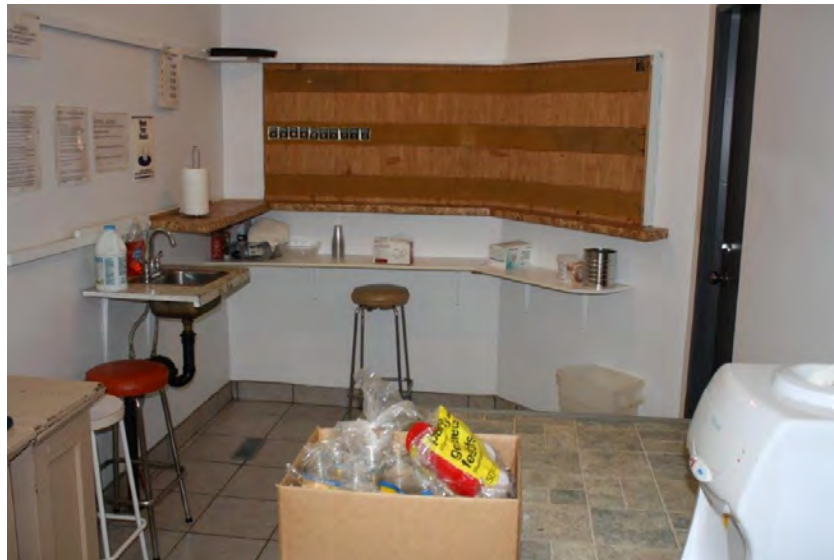
Photograph 26: Inside the concession in the hall (June 23, 2021).

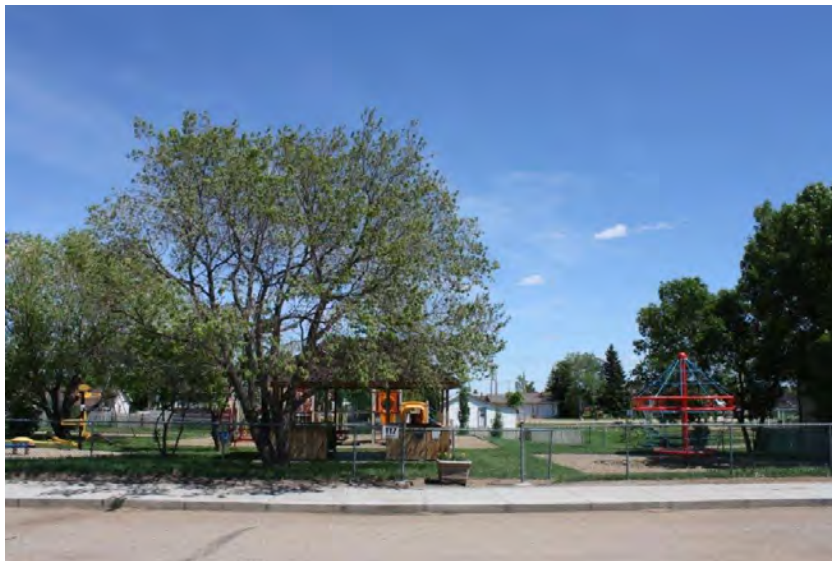
Photograph 32: Looking east across main street towards the Playground (June 23, 2021).

Phase II ESAs are recommended on the Church, Curling Rink, Berry Street Campground, Community Hall, Water Tower, Playground, Fire Hall and Canada Post and Bank building due to the proximity of offsite fuel USTs. Soil and Groundwater samples be collected and analysed for respective parameters of potential concern based on the adjacent site operations.

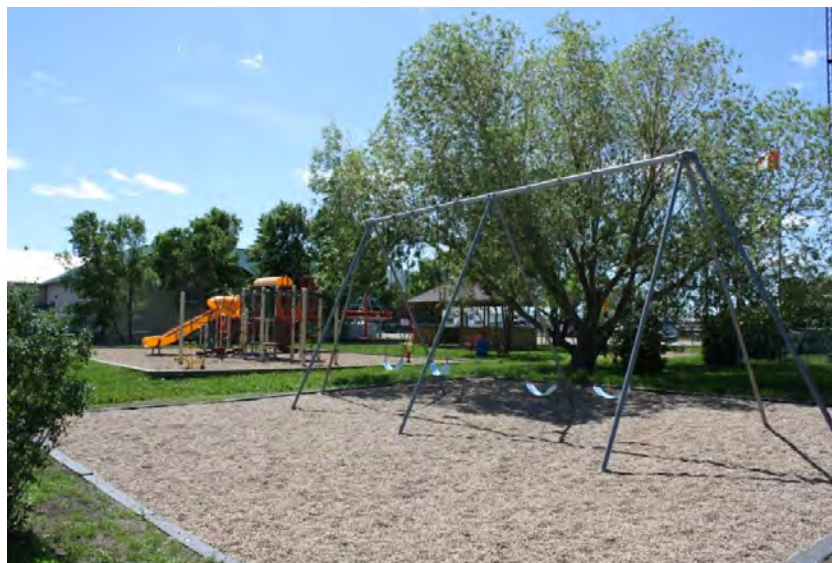
Photograph 34: Looking south over the Playground (June 23, 2021).

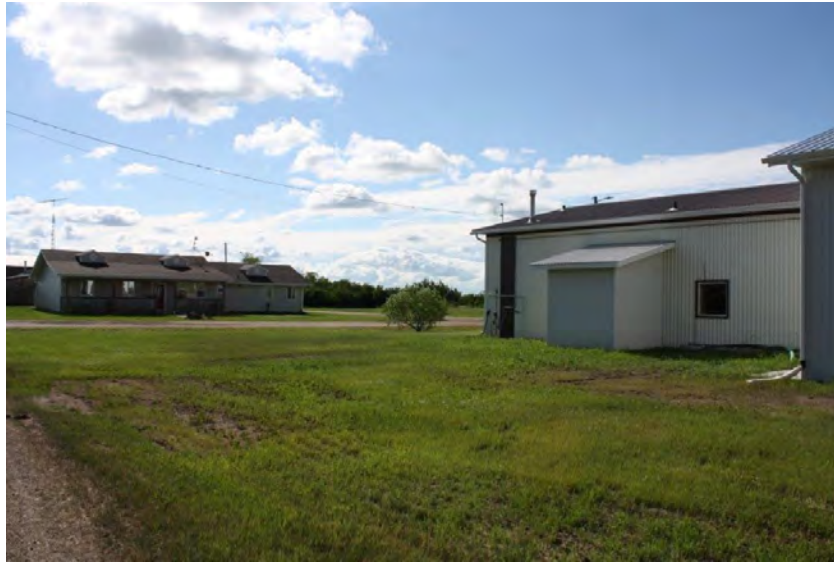
Photograph 37: Looking west over the north side of the Fire Hall (June 23, 2021).

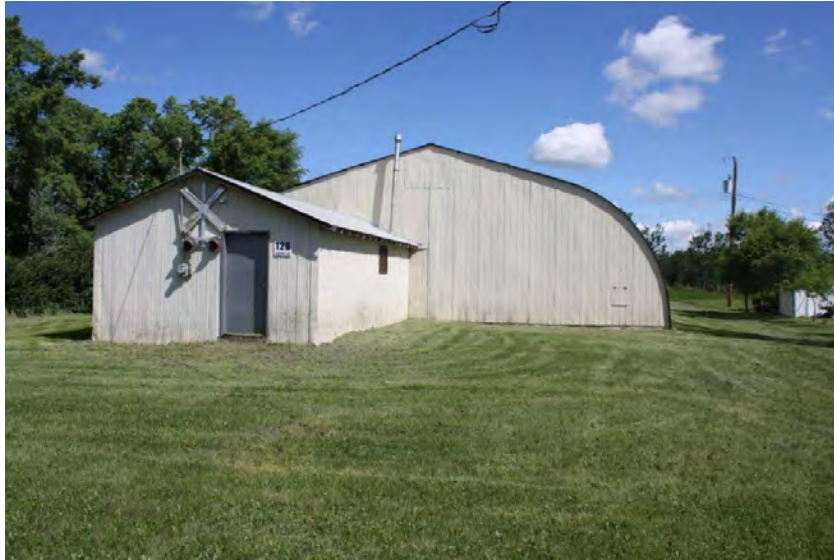
Photograph 1: Looking north at the Mini arena from Alberta Avenue (June 23, 2021).

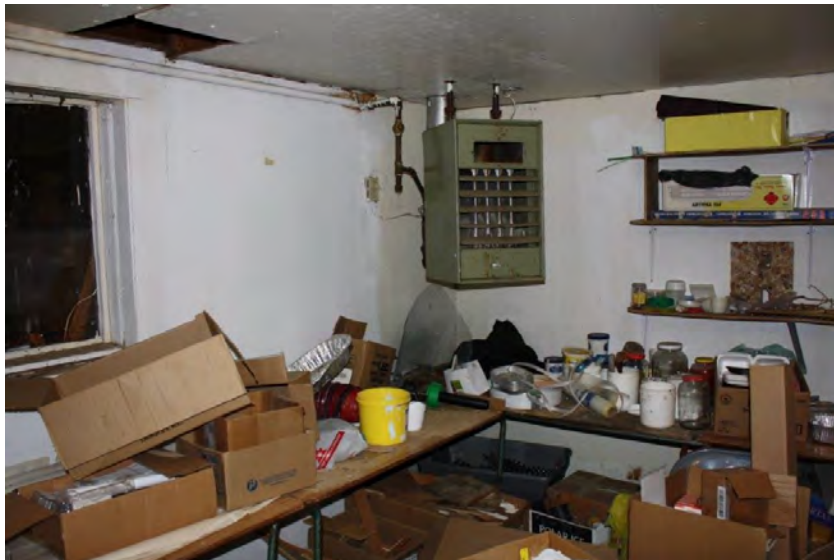
Photograph 2: Storage in the south addition of the Mini Arena (June 23, 2021).

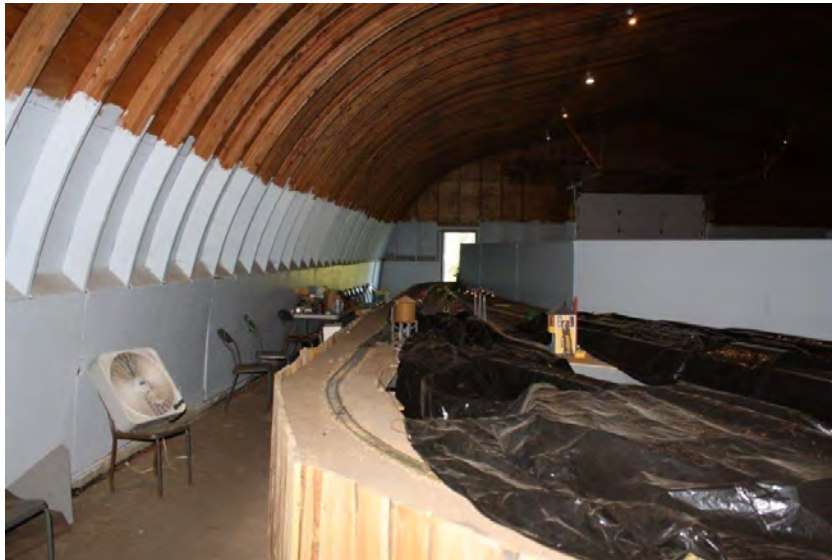
Photograph 3: Looking north along the west side of the Mini Arena (June 23, 2021).

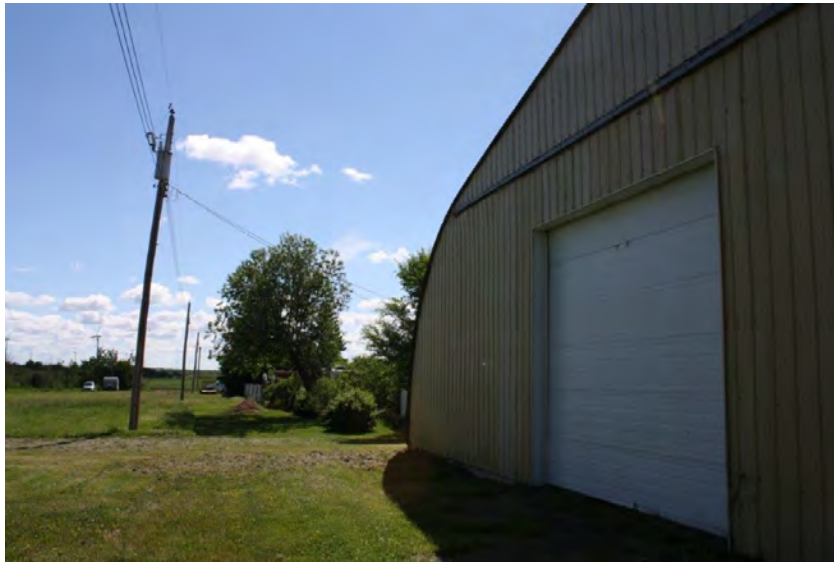
Photograph 7: The north portion of the Mini Arena Property (June 23, 2021).
